# BLAIR COUNTY ROAD-STREAM CROSSING ASSESSMENT

Prepared for:  
Blair County Conservation District  
1407 Blair Street  
Hollidaysburg, PA 16648

Prepared by:  
Western Pennsylvania Conservancy  
405 Allegheny Street  
Hollidaysburg, PA 16648  
(814) 696-9356

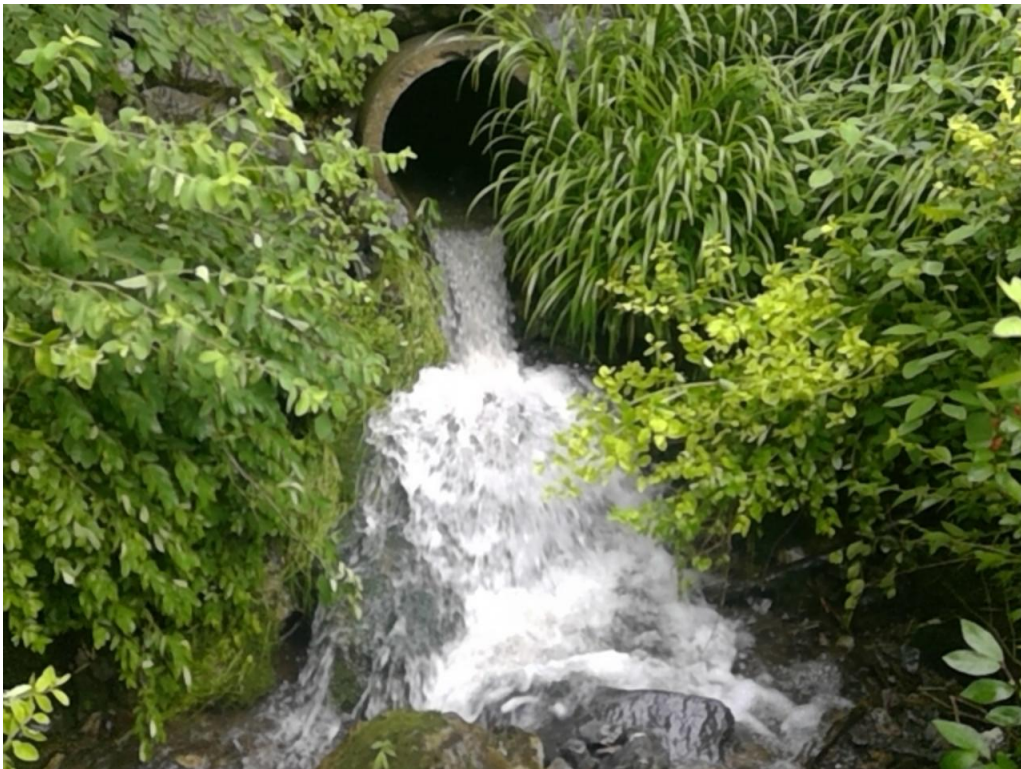
**Photo 1: Crossing 905 on Bear Wallow Road. This crossing is severely constricted and is a severe AOP barrier.**

<i>Dark Blue cells indicate a rank in all three categories.</i>	<i>Medium Blue Cells indicate a rank in two categories.</i>	<i>Light Blue Cells indicate a rank in one category.</i>	
<b>Crossing Number</b>	<b>AOP Evaluation: Severe &amp; Significant Barriers</b>	<b>Constriction Condition: Severe</b>	<b>Crossing Condition: Poor</b>
893 - Maple Hollow Road		X	
896 - Maple Hollow Road		X	
897 - Maple Hollow Road		X	
898 - Mill Road	X	X	
899 - Mill Road	X	X	
900 - Mill Road	X		
905 - Bear Wallow Road <i>(Photo 1)</i>	X	X	
906 - Carson Valley Road		X

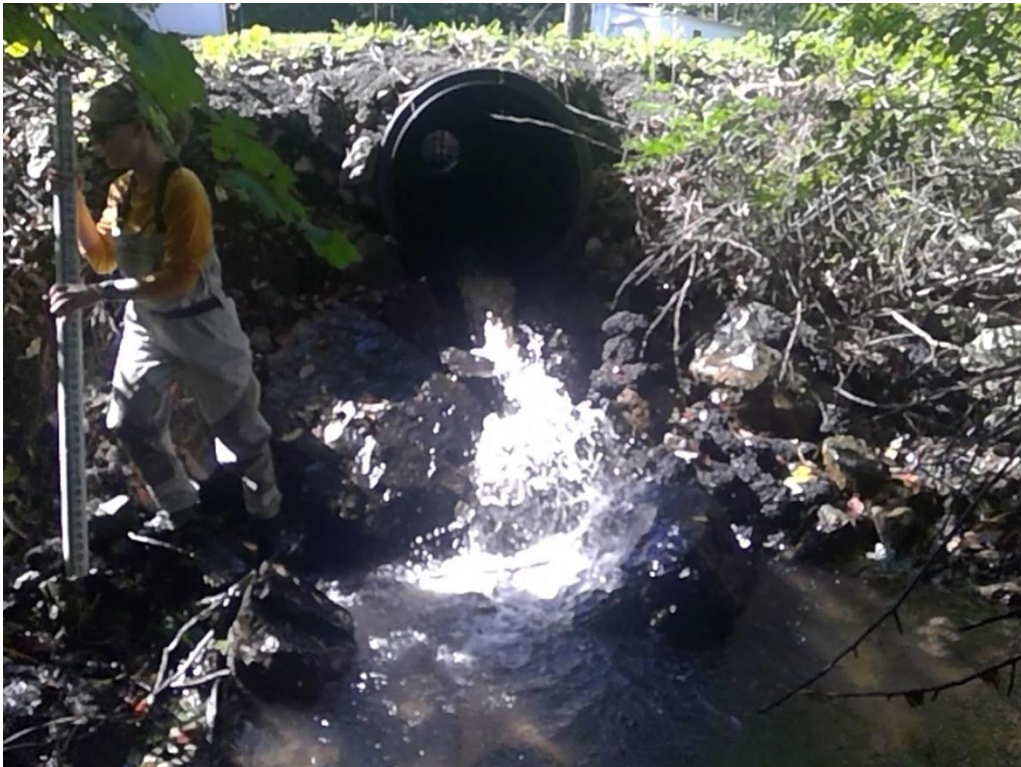
**Photo 1: Crossing 1146 on Hollen Road. This crossing is a severe AOP barrier.**

<i>Dark Blue cells indicate a rank in all three categories.</i>	<i>Medium Blue Cells indicate a rank in two categories.</i>	<i>Light Blue Cells indicate a rank in one category.</i>	
<b>Crossing Number</b>	<b>AOP Evaluation: Severe &amp; Significant Barriers</b>	<b>Constriction Condition: Severe</b>	<b>Crossing Condition: Poor</b>
1121 - Riggles Gap Road		X	
1124 - Riggles Gap Road		X	
1143 - Kerbaugh Road		X	X
1146 - Hollen Road <i>(Photo 1)</i>	X		
1150 - Tuckahoe road	X		
1152 - Bel Tip Road	X	X	X
1155 - Igou Road		X	
1160 - Tuckahoe Road		X

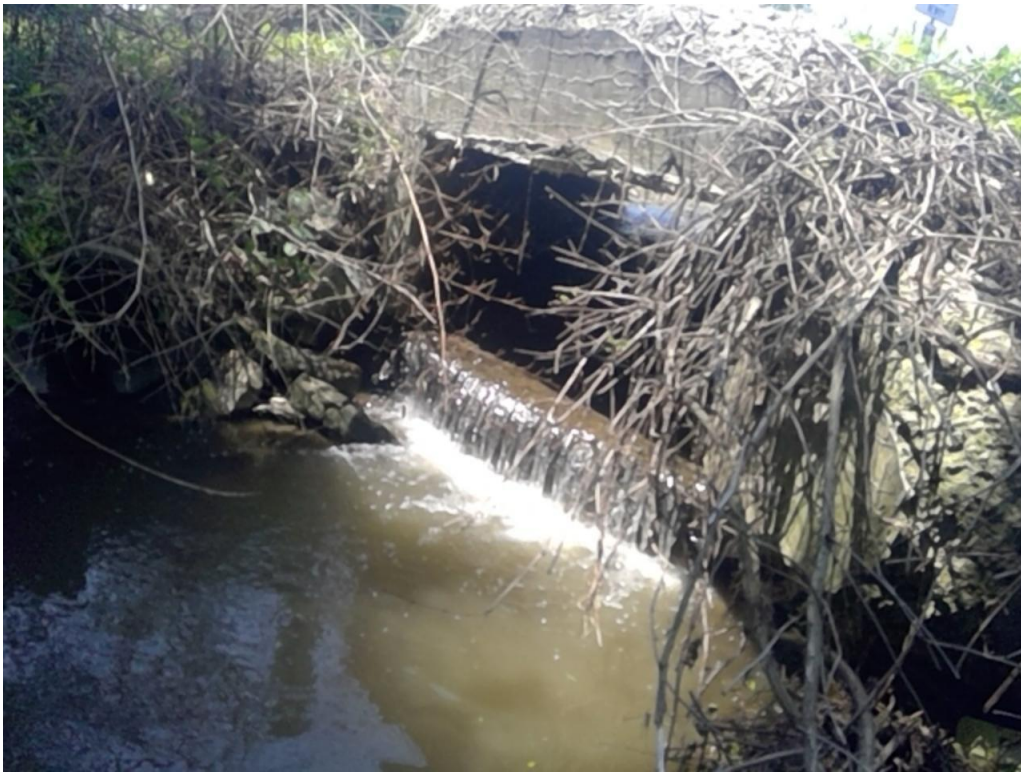
**Photo 1: Crossing 851 on Shamrock Lane. The outlet of the box culvert causes it to be a severe AOP barrier.**

<i>Dark Blue cells indicate a rank in all three categories.</i>	<i>Medium Blue Cells indicate a rank in two categories.</i>	<i>Light Blue Cells indicate a rank in one category.</i>	
<b>Crossing Number</b>	<b>AOP Evaluation: Severe &amp; Significant Barriers</b>	<b>Constriction Condition: Severe</b>	<b>Crossing Condition: Poor</b>
851 - Shamrock Lane <i>(Photo 1)</i>	X

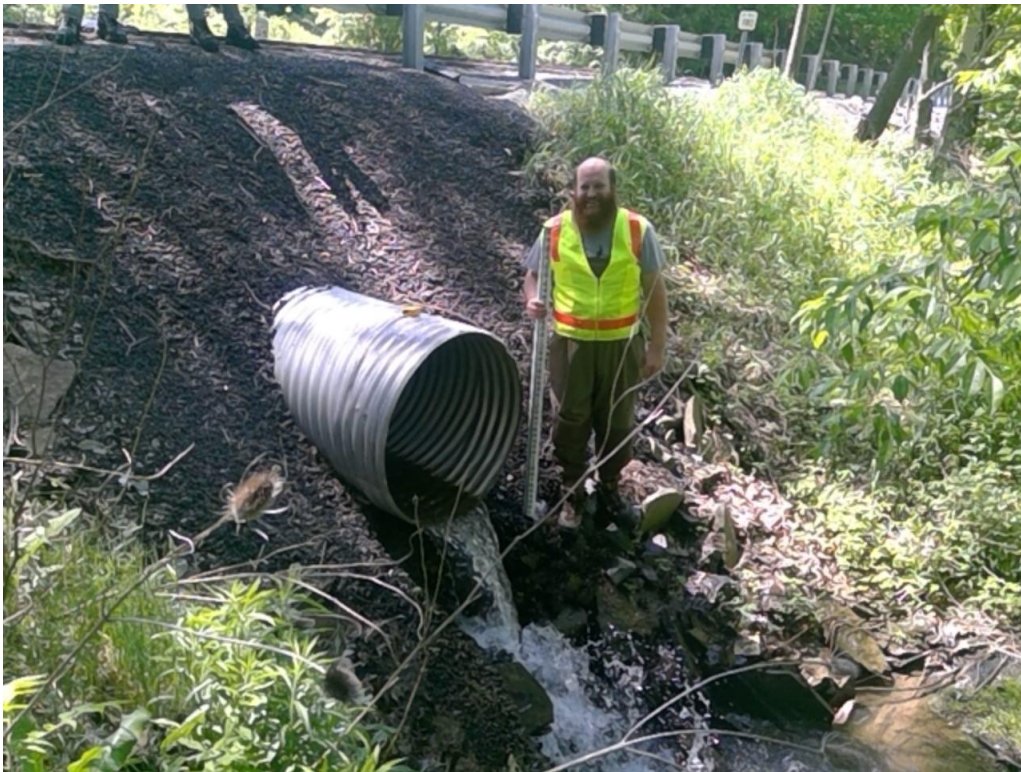
**Photo 1: Crossing 691 on Knob Road has a perched outlet that causes a severe AOP barrier.**

<i>Dark Blue cells indicate a rank in all three categories.</i>	<i>Medium Blue Cells indicate a rank in two categories.</i>	<i>Light Blue Cells indicate a rank in one category.</i>	
<b>Crossing Number</b>	<b>AOP Evaluation: Severe &amp; Significant Barriers</b>	<b>Constriction Condition: Severe</b>	<b>Crossing Condition: Poor</b>
691 - Knob Run Road <i>(Photo 1)</i>	X		
692 - Knob Run Road		X

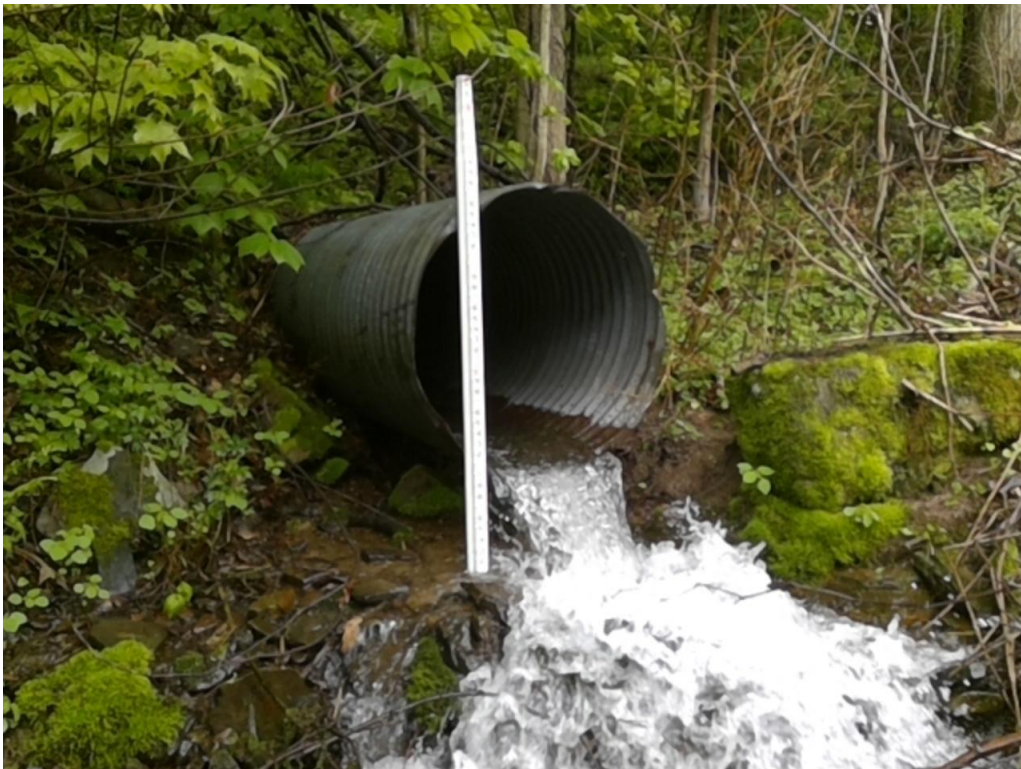
**Photo 1: Crossing 644 located on Overland Pass. The culvert is severely constricted and is a severe AOP barrier.**

<i>Dark Blue cells indicate a rank in all three categories.</i>	<i>Medium Blue Cells indicate a rank in two categories.</i>	<i>Light Blue Cells indicate a rank in one category.</i>	
<b>Crossing Number</b>	<b>AOP Evaluation: Severe &amp; Significant Barriers</b>	<b>Constriction Condition: Severe</b>	<b>Crossing Condition: Poor</b>
642 - Ski Gap Road		X	X
644 - Overland Pass <i>(Photo 1)</i>	X	X	
650 - Overland Pass		X

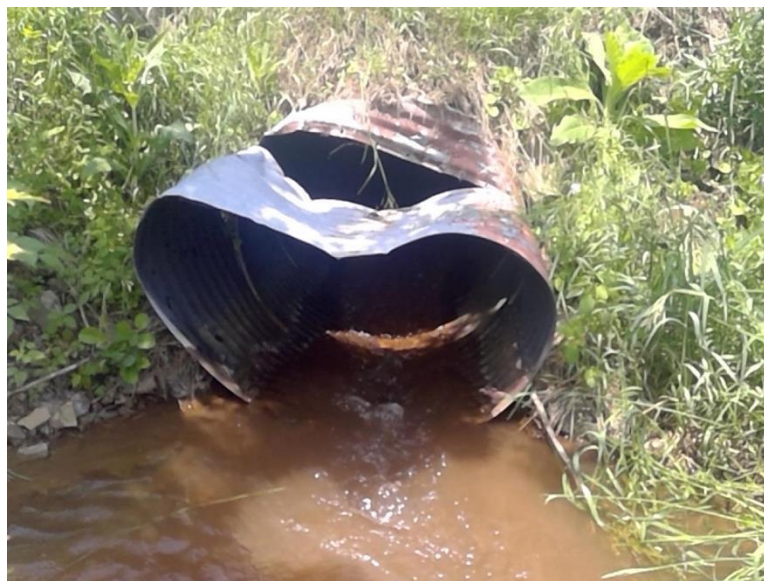
Crossing condition takes into account very old crossing pipes that are either rusting, collapsing, or eroding the road surface. Four crossings (839, 843, 845 & 878) in the township had poor crossing conditions (Figure 3). Crossing 837 was completely collapsed. We could not see the outlet pipe, and the stream is diverted into a road ditch. Crossing 878 had a slightly deformed pipe with the bottom rusted away.

**Photo 1: Crossing 843 on Valley Forge Road is in bad condition.**

<i>Dark Blue cells indicate a rank in all three categories.</i>	<i>Medium Blue Cells indicate a rank in two categories.</i>	<i>Light Blue Cells indicate a rank in one category.</i>	
<b>Crossing Number</b>	<b>AOP Evaluation: Severe &amp; Significant Barriers</b>	<b>Constriction Condition: Severe</b>	<b>Crossing Condition: Poor</b>
681 - Burket Hollow Road	X		
683 - Burket Hollow Road	X		
835 - 6 to 10 trail	X	X	
836 - 6 to 10 trail		X	
839 - Old US 22		X	X
841 - Old US 22	X		
843 - Valley Forge Road <i>(Photo 1)</i>			X
844 - Dry Run Road	X		
845 - Weaver Road		X	X
846 - Dry Run Road		X	
872 - Poplar Run Road	X	X	
873 - Poplar Run Road	X		
877 - Longenecker Road		X	
878 Poplar Run Road	X	X	X
879 - Poplar Run Road	X

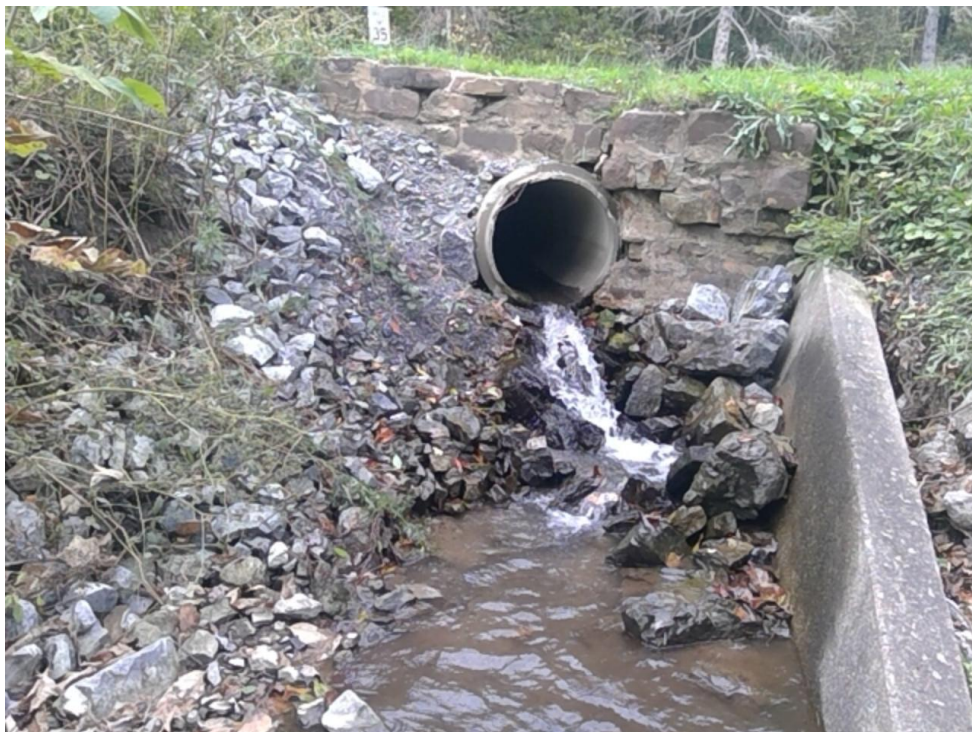
**Photo 1: Crossing 1216 on Avalon Road is a severe AOP barrier.**

<i>Dark Blue cells indicate a rank in all three categories.</i>	<i>Medium Blue Cells indicate a rank in two categories.</i>	<i>Light Blue Cells indicate a rank in one category.</i>	
<b>Crossing Number</b>	<b>AOP Evaluation: Severe &amp; Significant Barriers</b>	<b>Constriction Condition: Severe</b>	<b>Crossing Condition: Poor</b>
1052 - Veterans Memorial HWY	X		
1104 - E Third Avenue		X	
1107 - E Hamilton lane		X	
1112 - Rosehill Drive Ext		X	
1134 - Dartmouth Lane		X	
1208 - Juniata Gap Road	X		
1212 - Wopsy Road	X		
1213 - Lookout Avenue			X
1214 - Park Drive		X	
1215 - Logandale Drive		X	
1216 - Avalon Road <i>(Photo 1)</i>	X

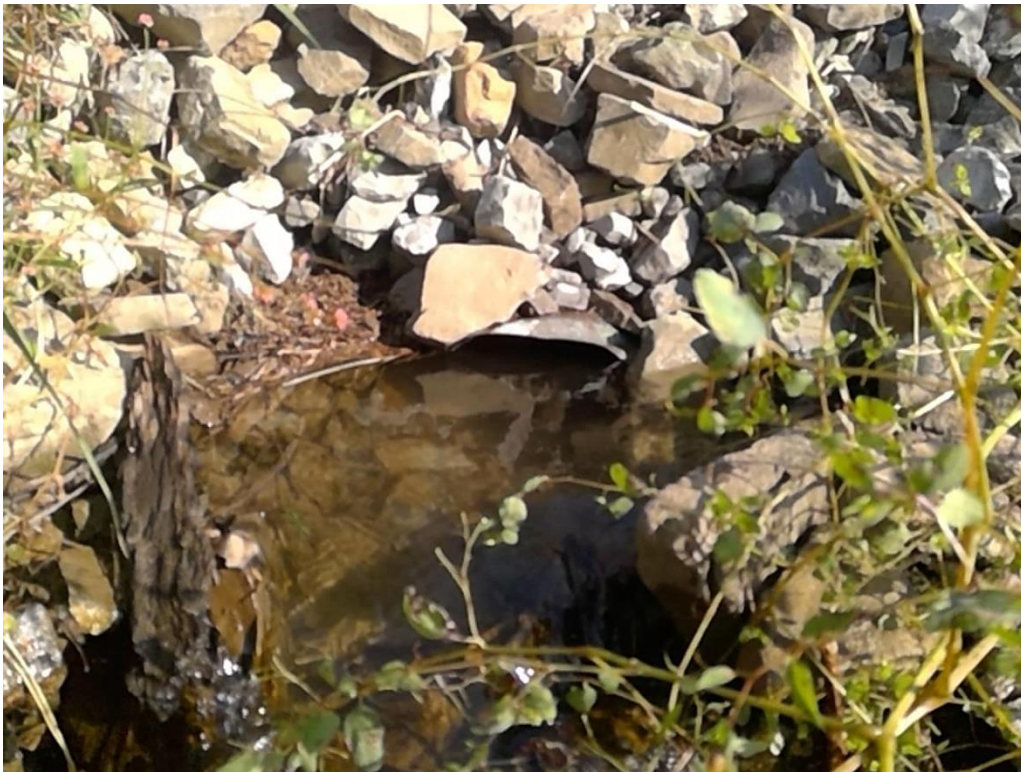
**Photo 1: Crossing 1068 on Plum Creek Road. This crossing is almost completely filled with sediment and is a severe AOP barrier.**

<i>Dark Blue cells indicate a rank in all three categories.</i>	<i>Medium Blue Cells indicate a rank in two categories.</i>	<i>Light Blue Cells indicate a rank in one category.</i>	
<b>Crossing Number</b>	<b>AOP Evaluation: Severe &amp; Significant Barriers</b>	<b>Constriction Condition: Severe</b>	<b>Crossing Condition: Poor</b>
1065 - Plum Creek Road	X		
1066 - Plum Creek BLVD	X		
1068 - Plum Creek Road <i>(Photo 1)</i>	X	X	X

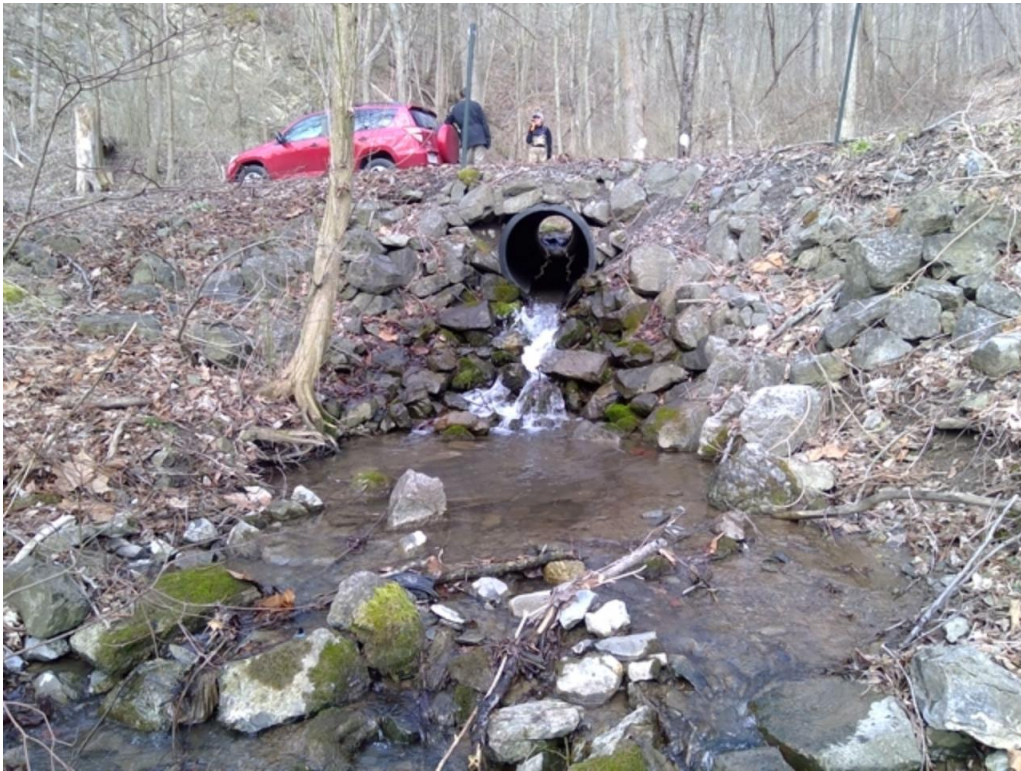
**Photo 1: Crossing 635 on Wertz Road. This crossing is located on a UNT to Piney Creek. It is a severe AOP barrier.**

<i>Dark Blue cells indicate a rank in all three categories.</i>	<i>Medium Blue Cells indicate a rank in two categories.</i>	<i>Light Blue Cells indicate a rank in one category.</i>	
<b>Crossing Number</b>	<b>AOP Evaluation: Severe &amp; Significant Barriers</b>	<b>Constriction Condition: Severe</b>	<b>Crossing Condition: Poor</b>
633 - Royer Road			X
635 - Wertz Road <i>(Photo 1)</i>	X		
636 - Wertz Road	X
