# BLAIR COUNTY ROAD-STREAM CROSSING ASSESSMENT

Prepared for:  
Blair County Conservation District  
1407 Blair Street  
Hollidaysburg, PA 16648

Prepared by:  
Western Pennsylvania Conservancy  
405 Allegheny Street  
Hollidaysburg, PA 16648  
(814) 696-9356

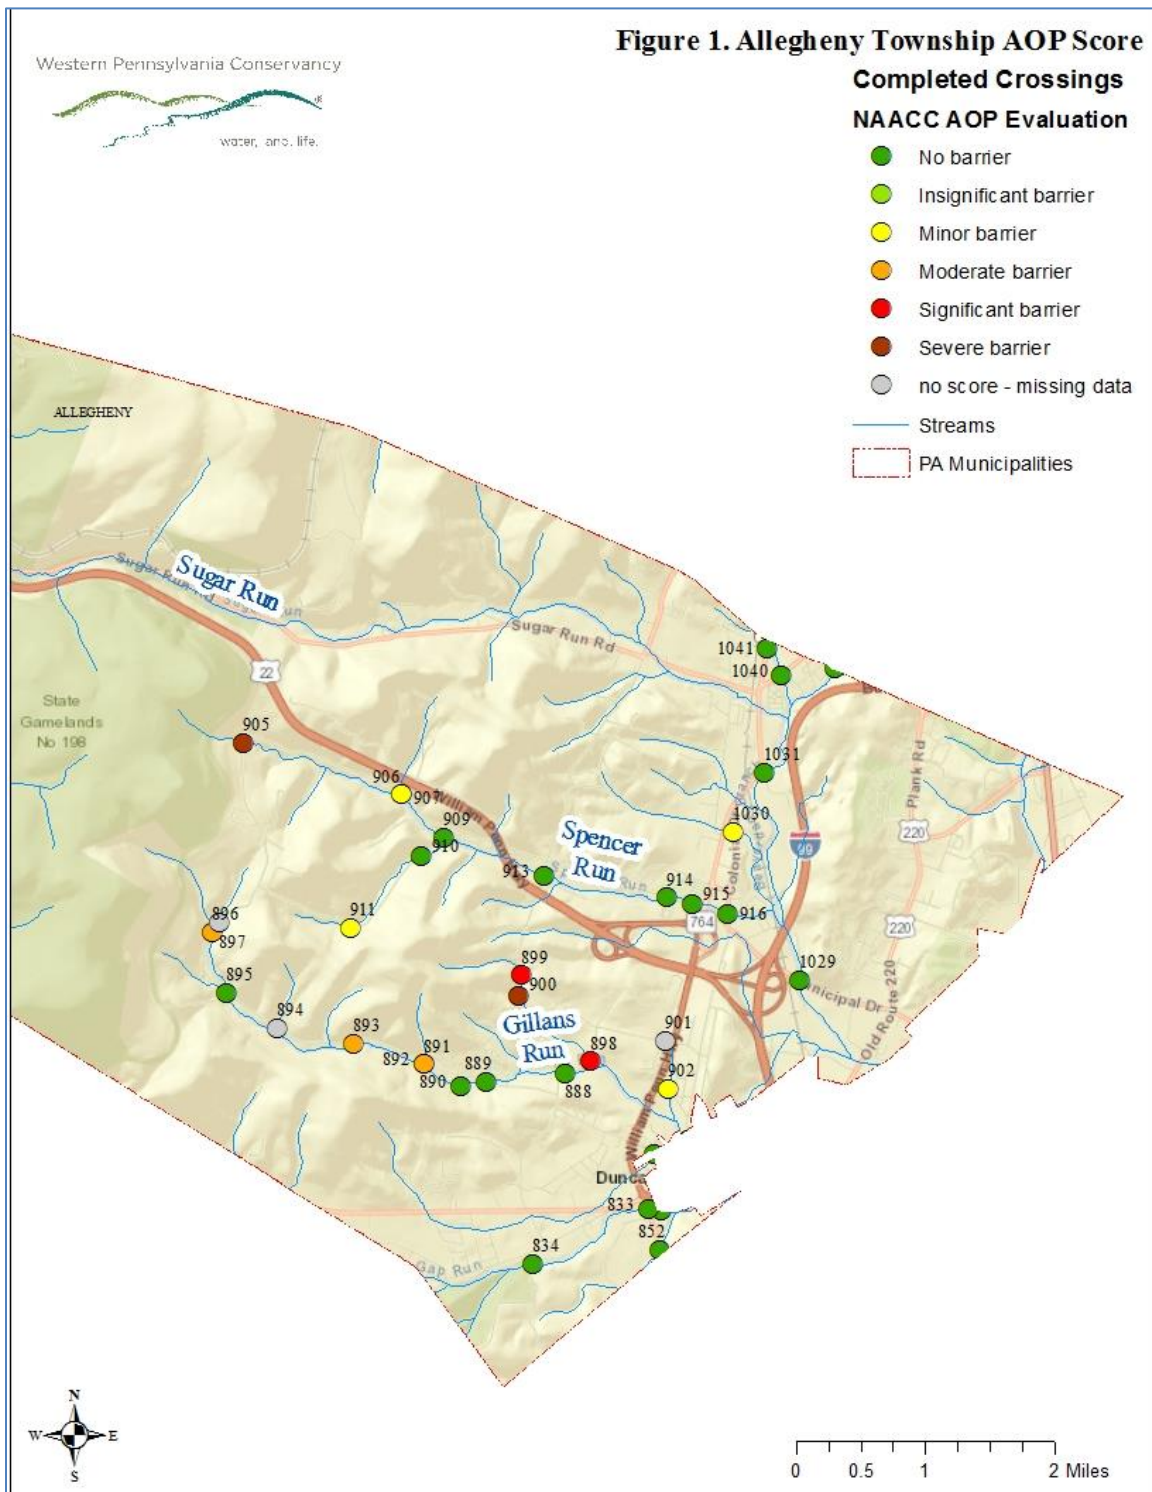
In Allegheny Township, 31 road-stream crossings were surveyed. Based upon NAACC assessment data, two of these crossings (900 & 905) were considered severe aquatic organism passage (AOP) barriers, and two crossings (898 & 899) were considered significant AOP barriers (Figure 1).

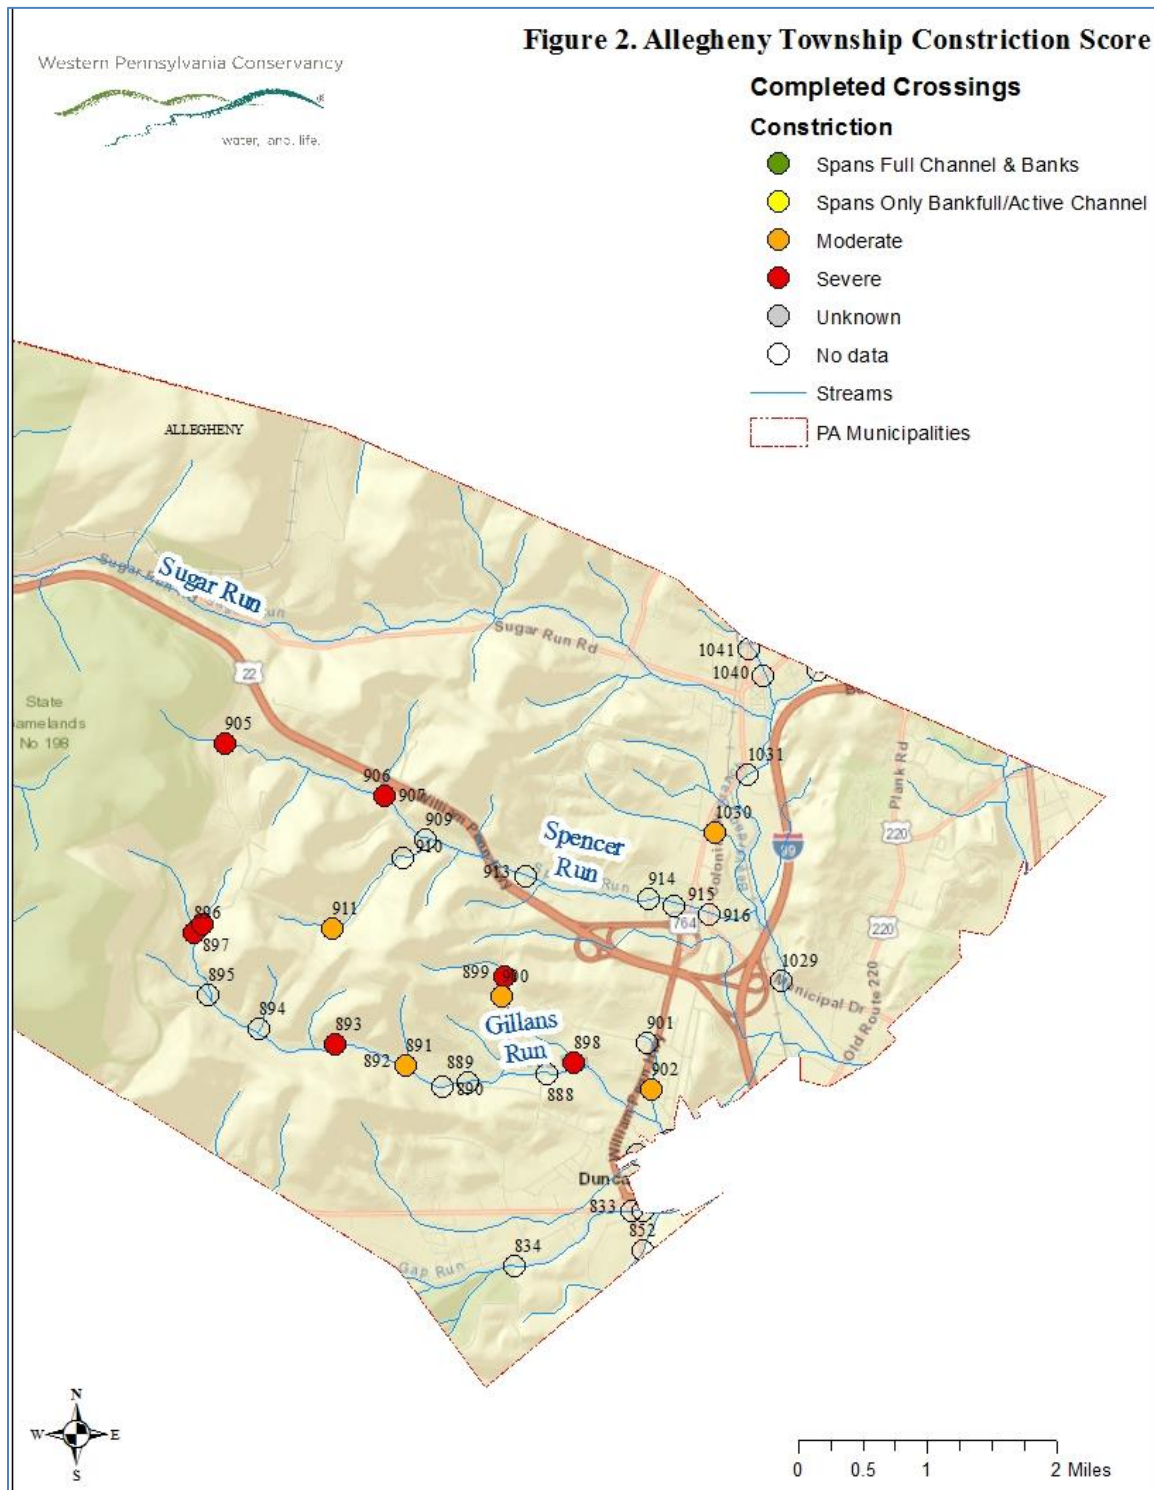
The constriction score assesses how the width of the crossing compares to the width of the natural stream channel. Road-stream crossings that have severe constriction scores are more likely to have erosion problems above and/or below the crossing. Figure 2 shows constriction scores for assessed crossings in Allegheny Township. Seven crossings show severe constriction scores, which increases the potential of erosion and sedimentation around those crossings.

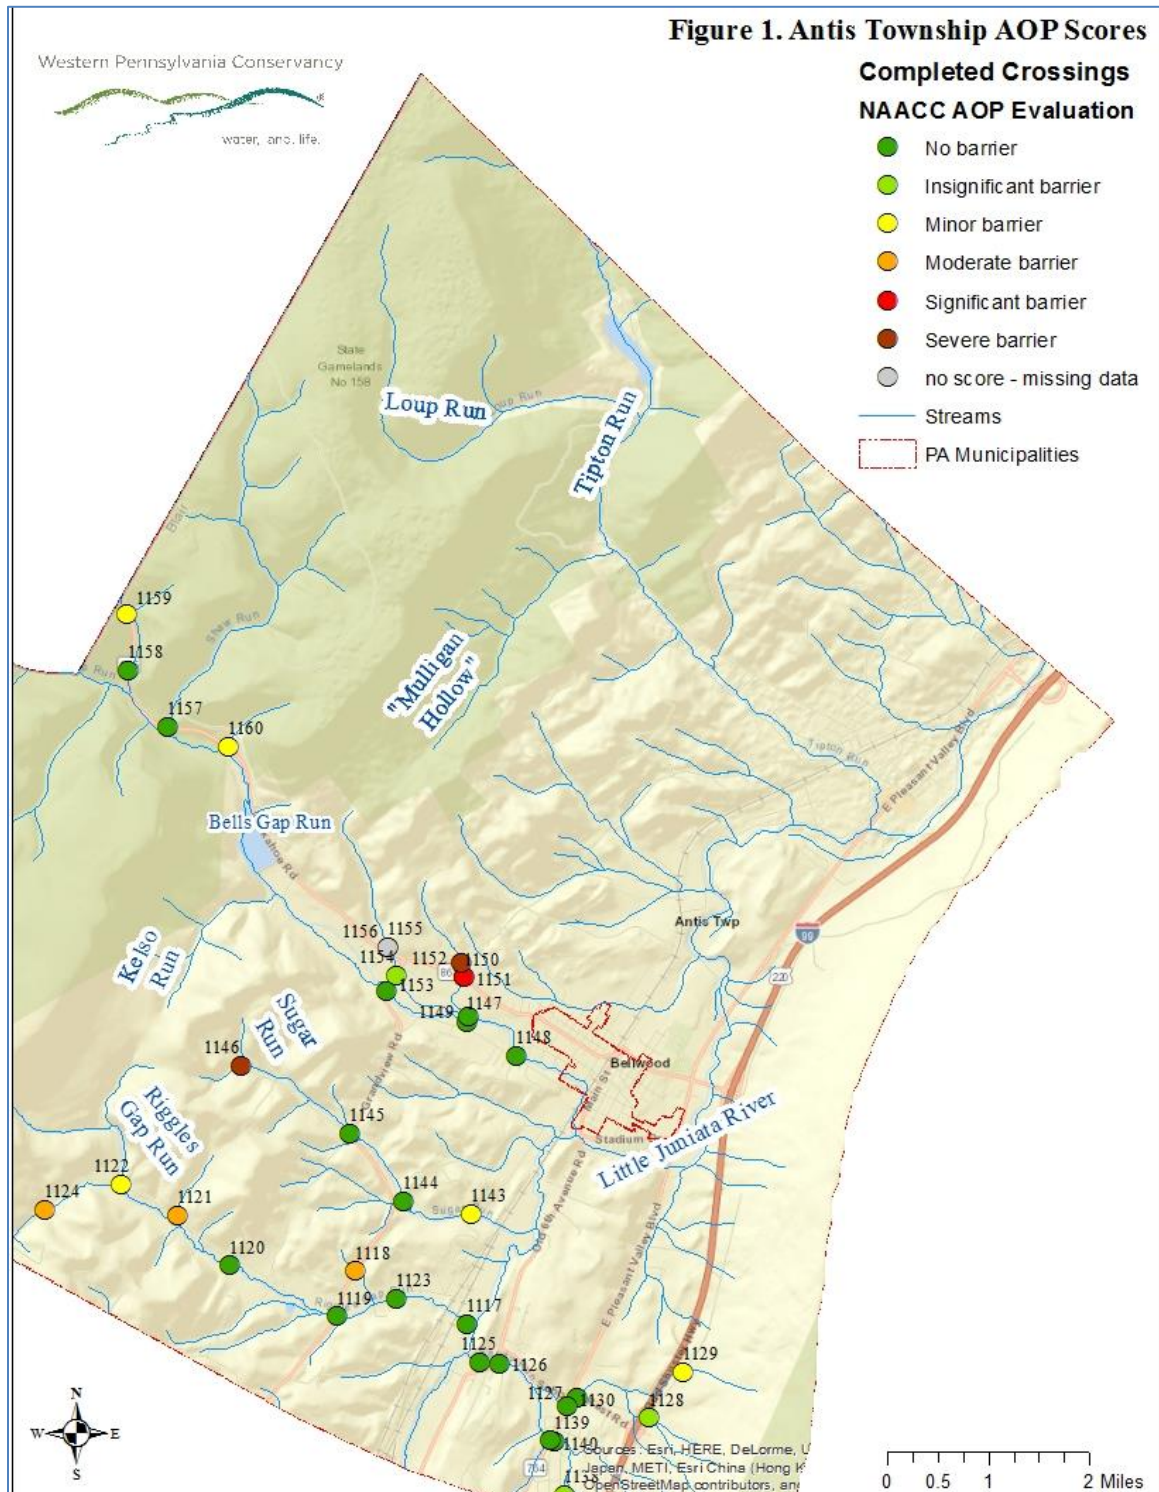
In Antis Township, 35 road-stream crossings were surveyed. Based upon NAACC assessment data, two of these crossings (1146 & 1152) were considered severe aquatic organism passage (AOP) barriers, and one crossing (1151) was considered a significant AOP barrier (Figure 1).

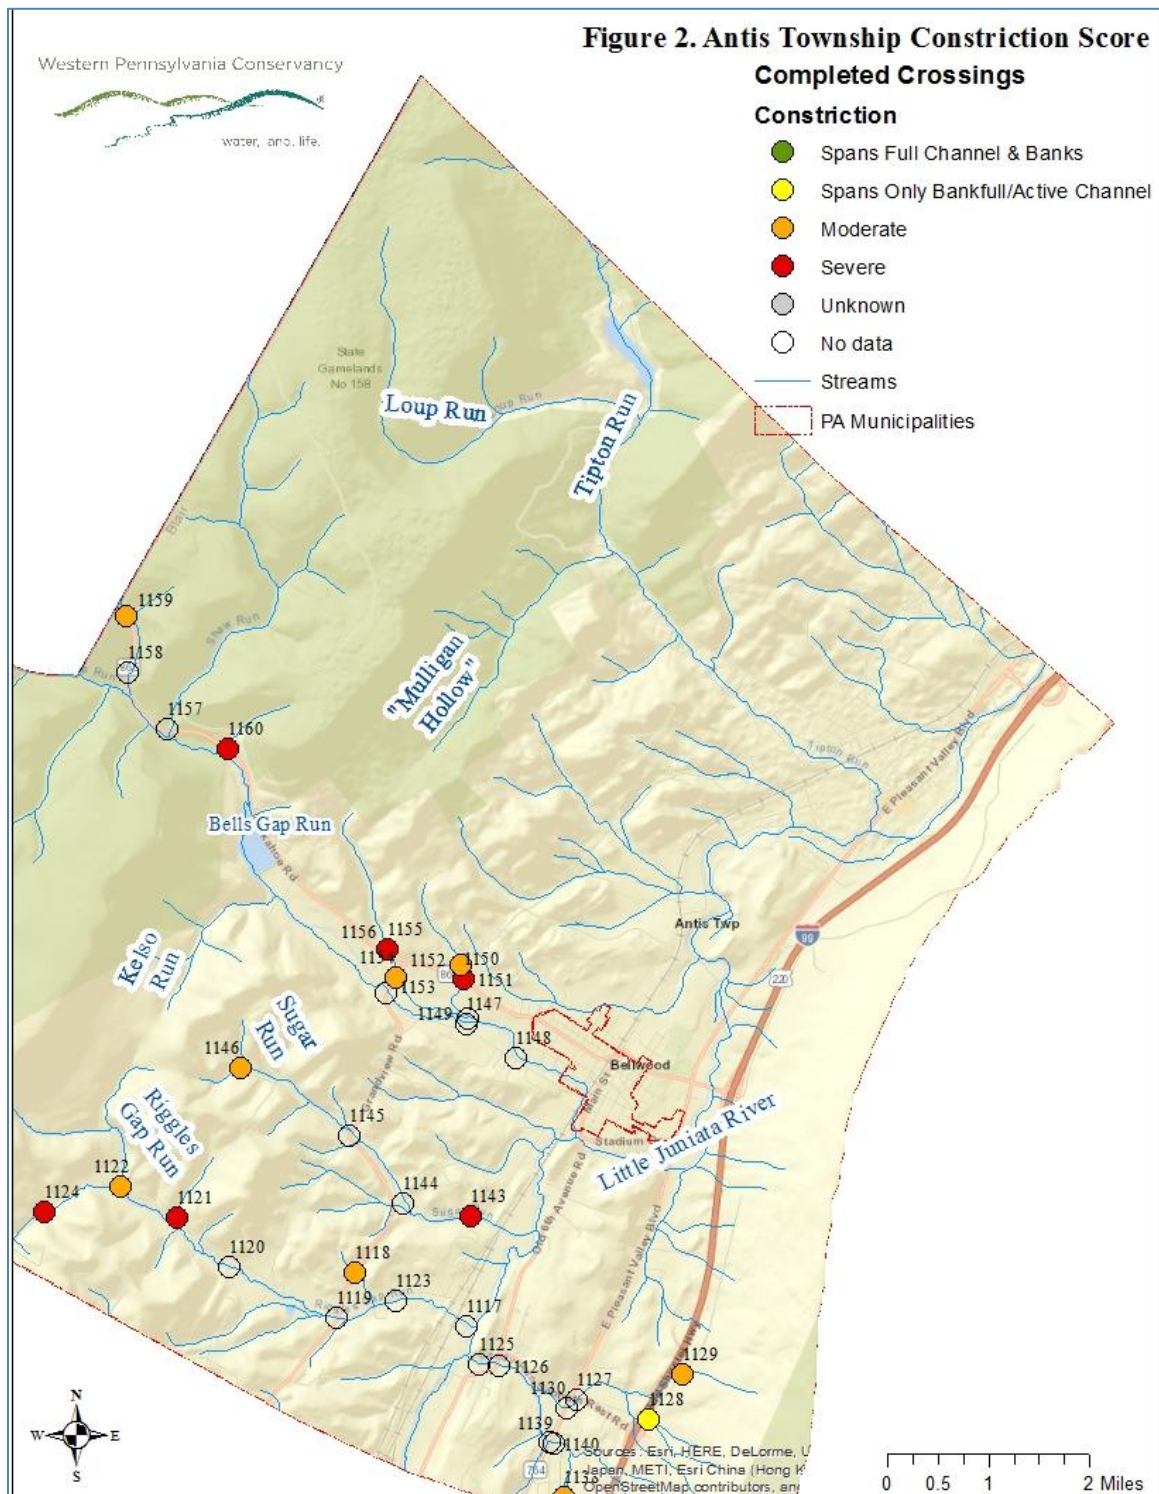
The constriction score assesses how the width of the crossing compares to the width of the natural stream channel. Road-stream crossings that have severe constriction scores are more likely to have erosion problems above and/or below the crossing. Figure 2 shows constriction scores for assessed crossings in Antis Township. Six crossings show severe constriction scores, which increases the potential of erosion and sedimentation around those crossings.

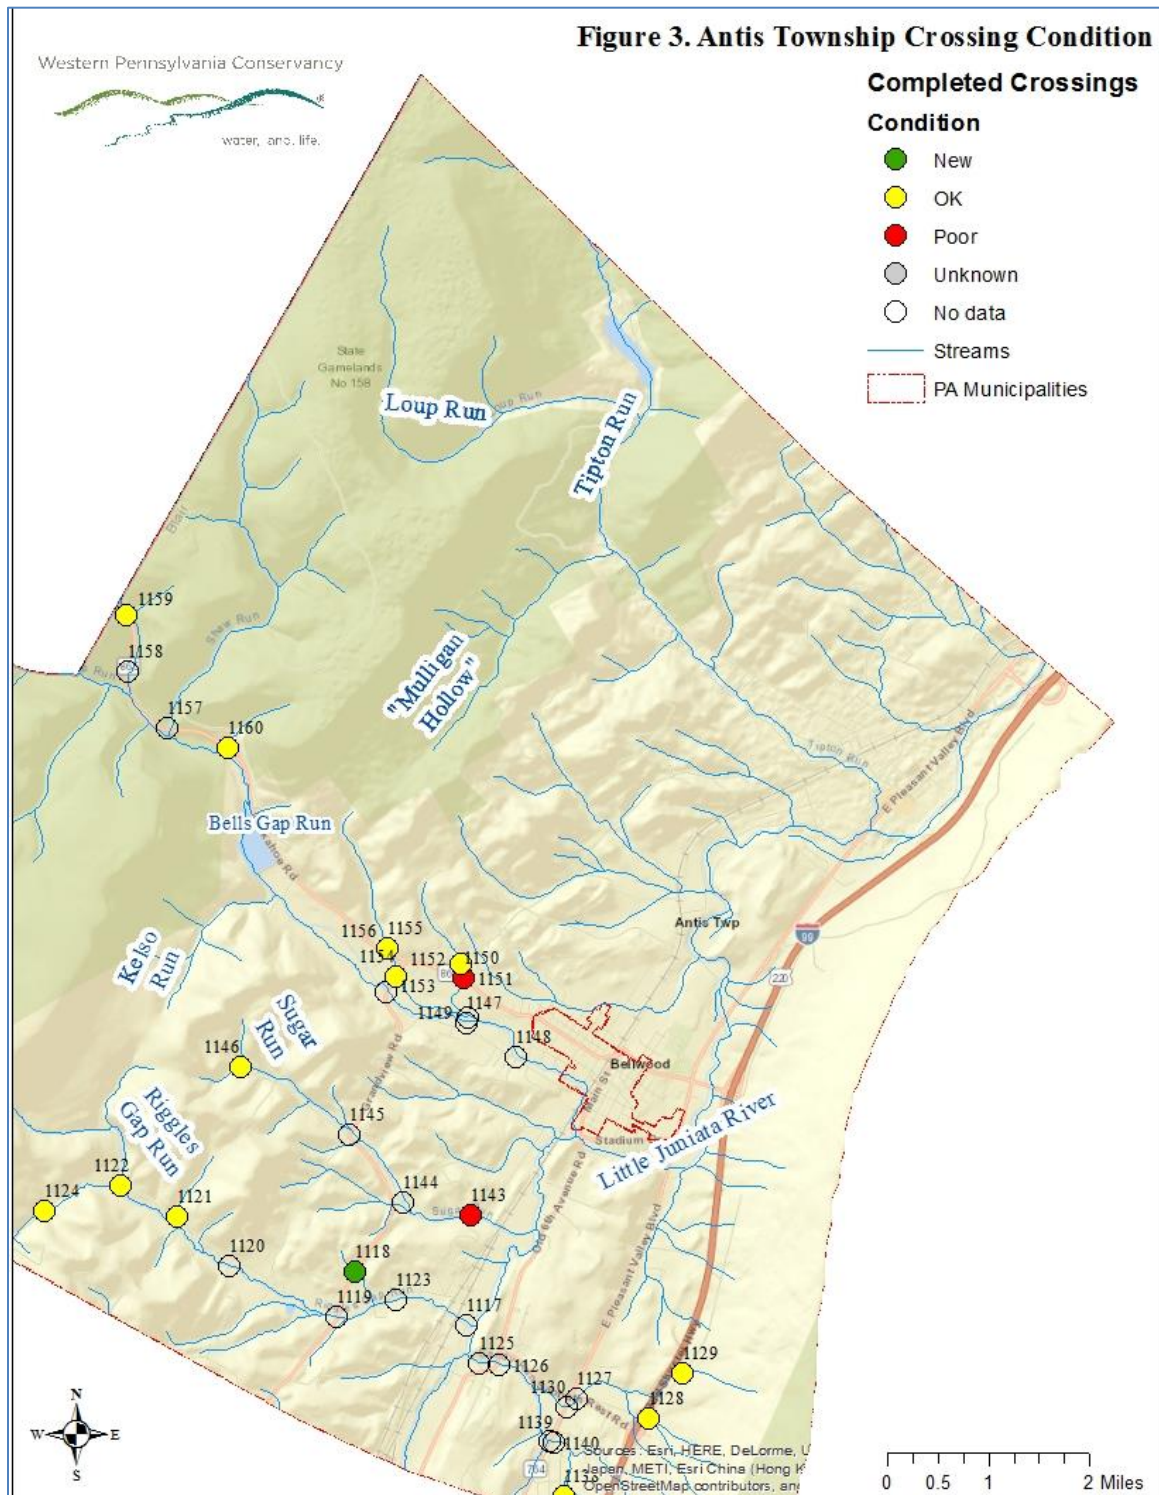
Crossing condition takes into account very old crossing pipes that are either rusting, collapsing, or eroding the road surface. Two crossings (1143 & 1152) in the township had poor crossing conditions (Figure 3). Crossing 1143 had a culvert pipe where the entire bottom was rusted away. Kerbaugh Road on the inlet side was also starting to collapse. Crossing 1151 had a culvert pipe that was broken halfway through the crossing and at the outlet end of the crossing. Additionally, there was a large amount of erosion at the inlet of the pipe that was almost reaching Tuckahoe Road.

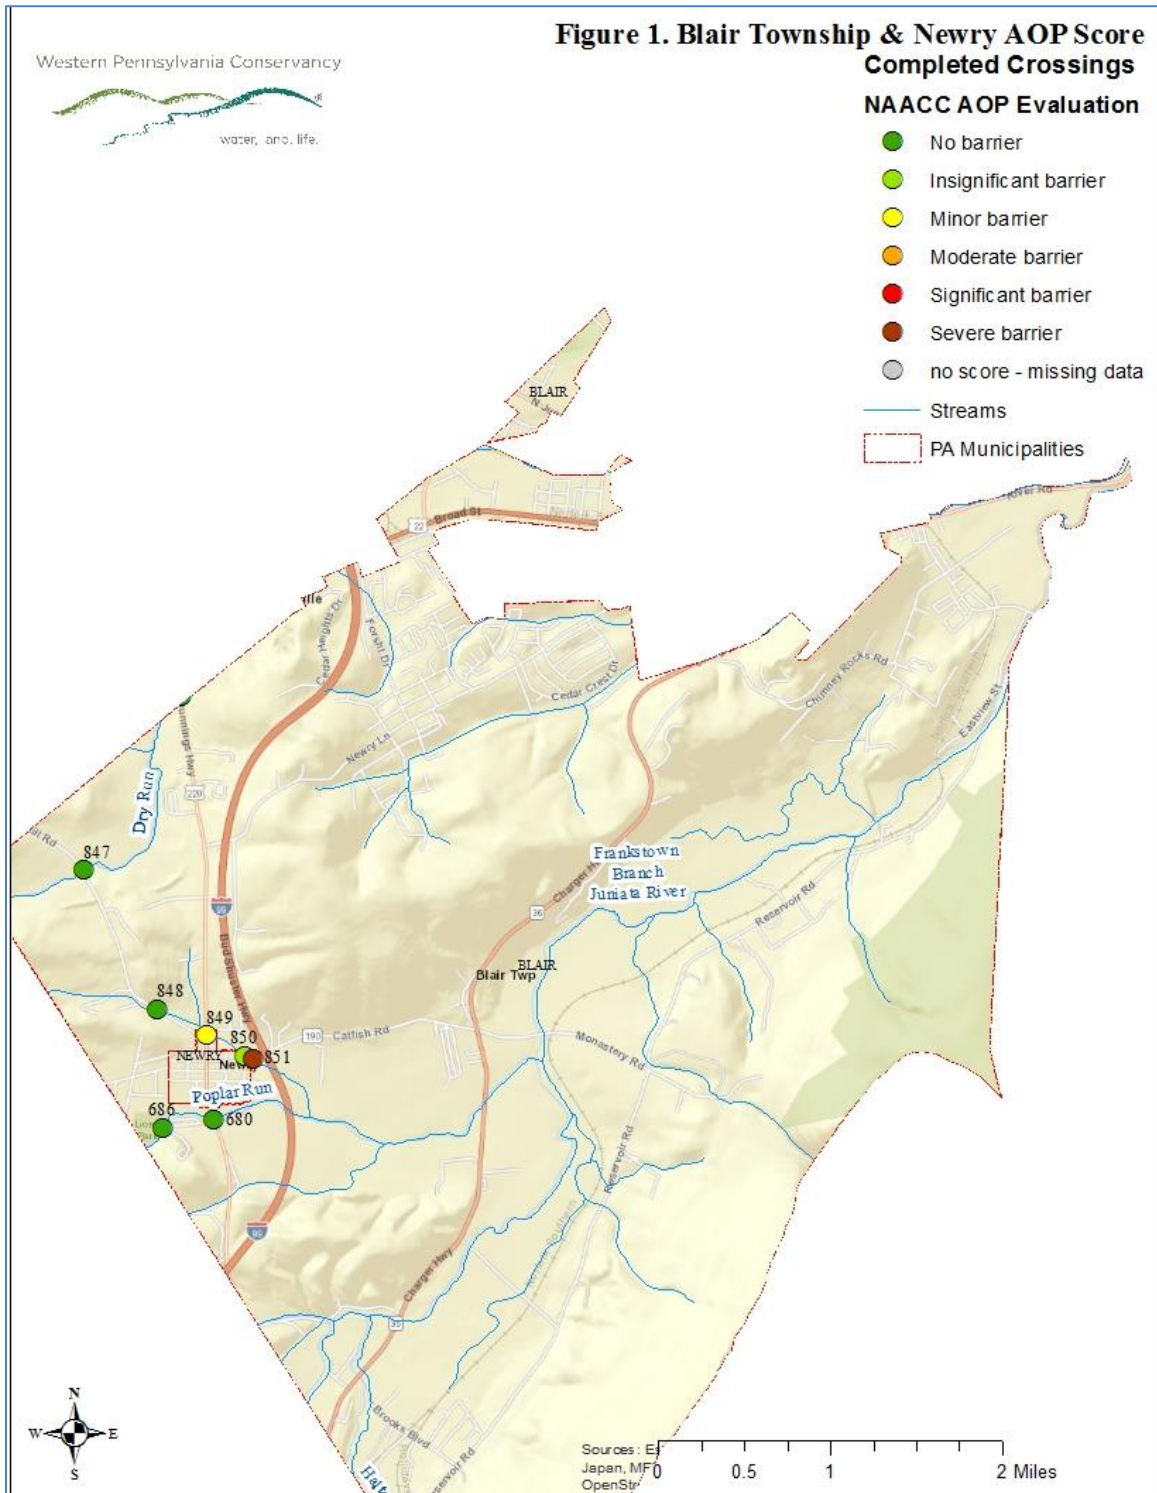
In Blair Township and Newry Borough, nine road-stream crossings were surveyed. Two of the mapped crossings were not actual crossings, but map errors. They have been removed from the database. Based upon NAACC assessment data, one crossing (851) was considered to be a severe aquatic organism passage (AOP) barrier (Figure 1).

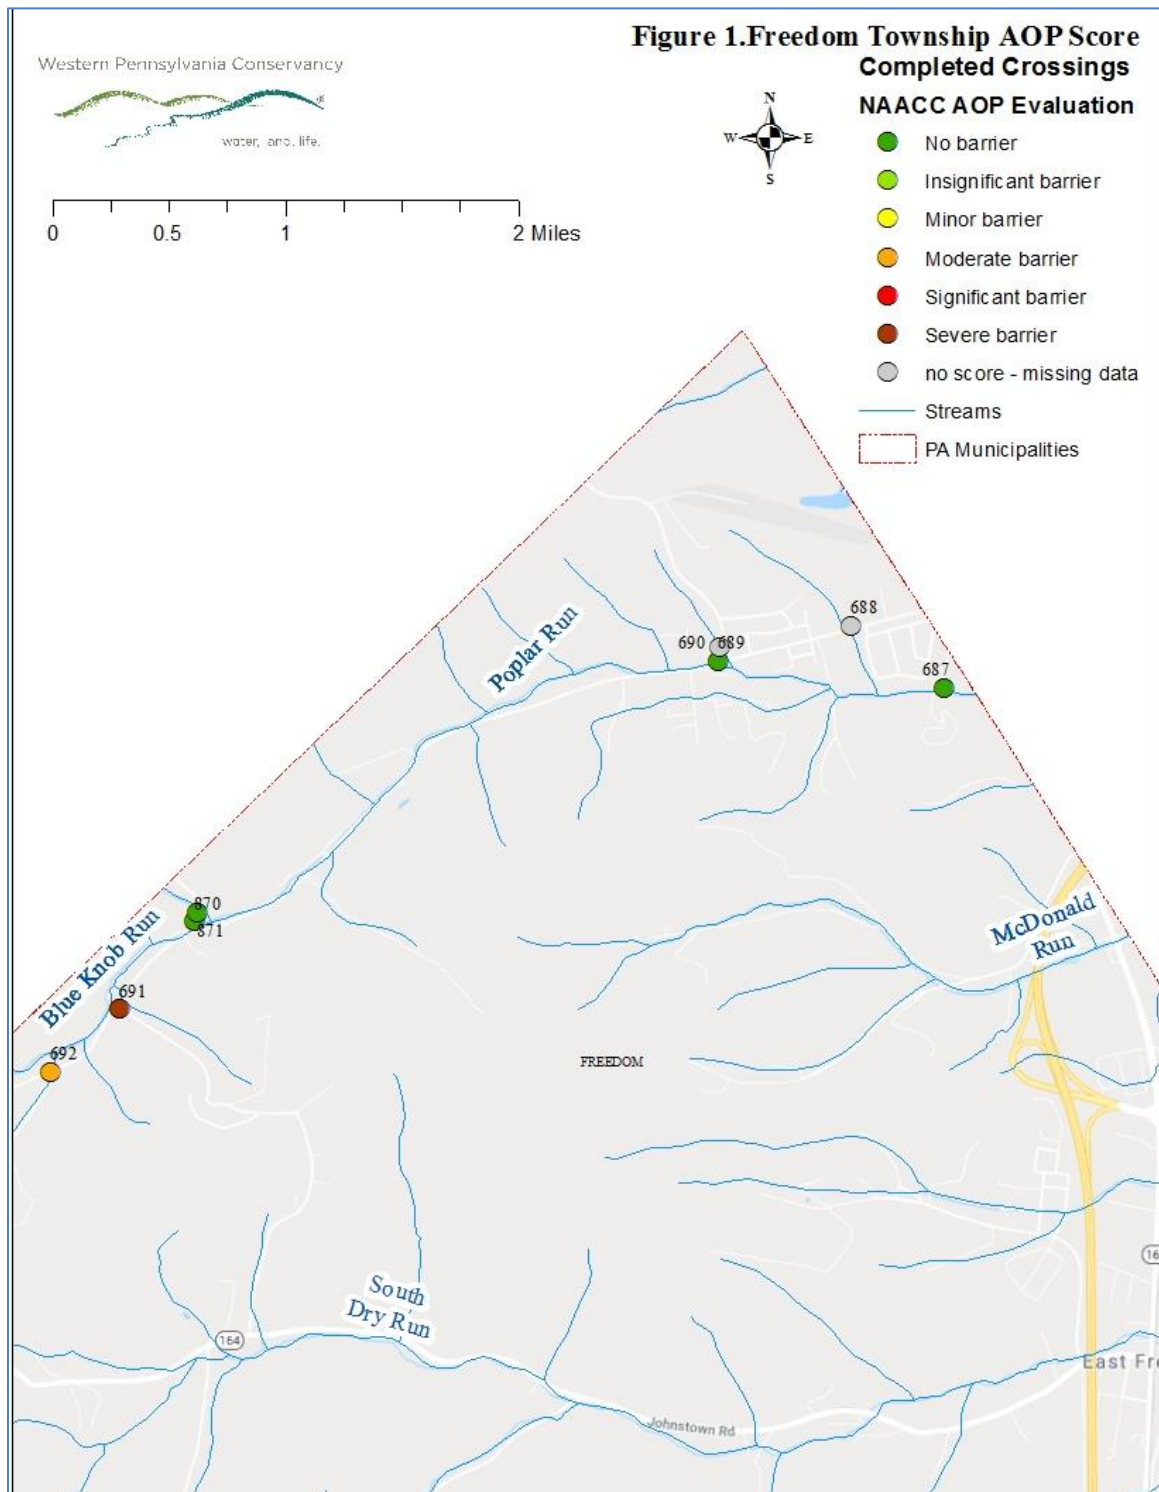
In Freedom Township, six road-stream crossings were surveyed. Based upon NAACC assessment data, one of these crossings (691) was considered to be a severe aquatic organism passage (AOP) barrier (Figure 1).

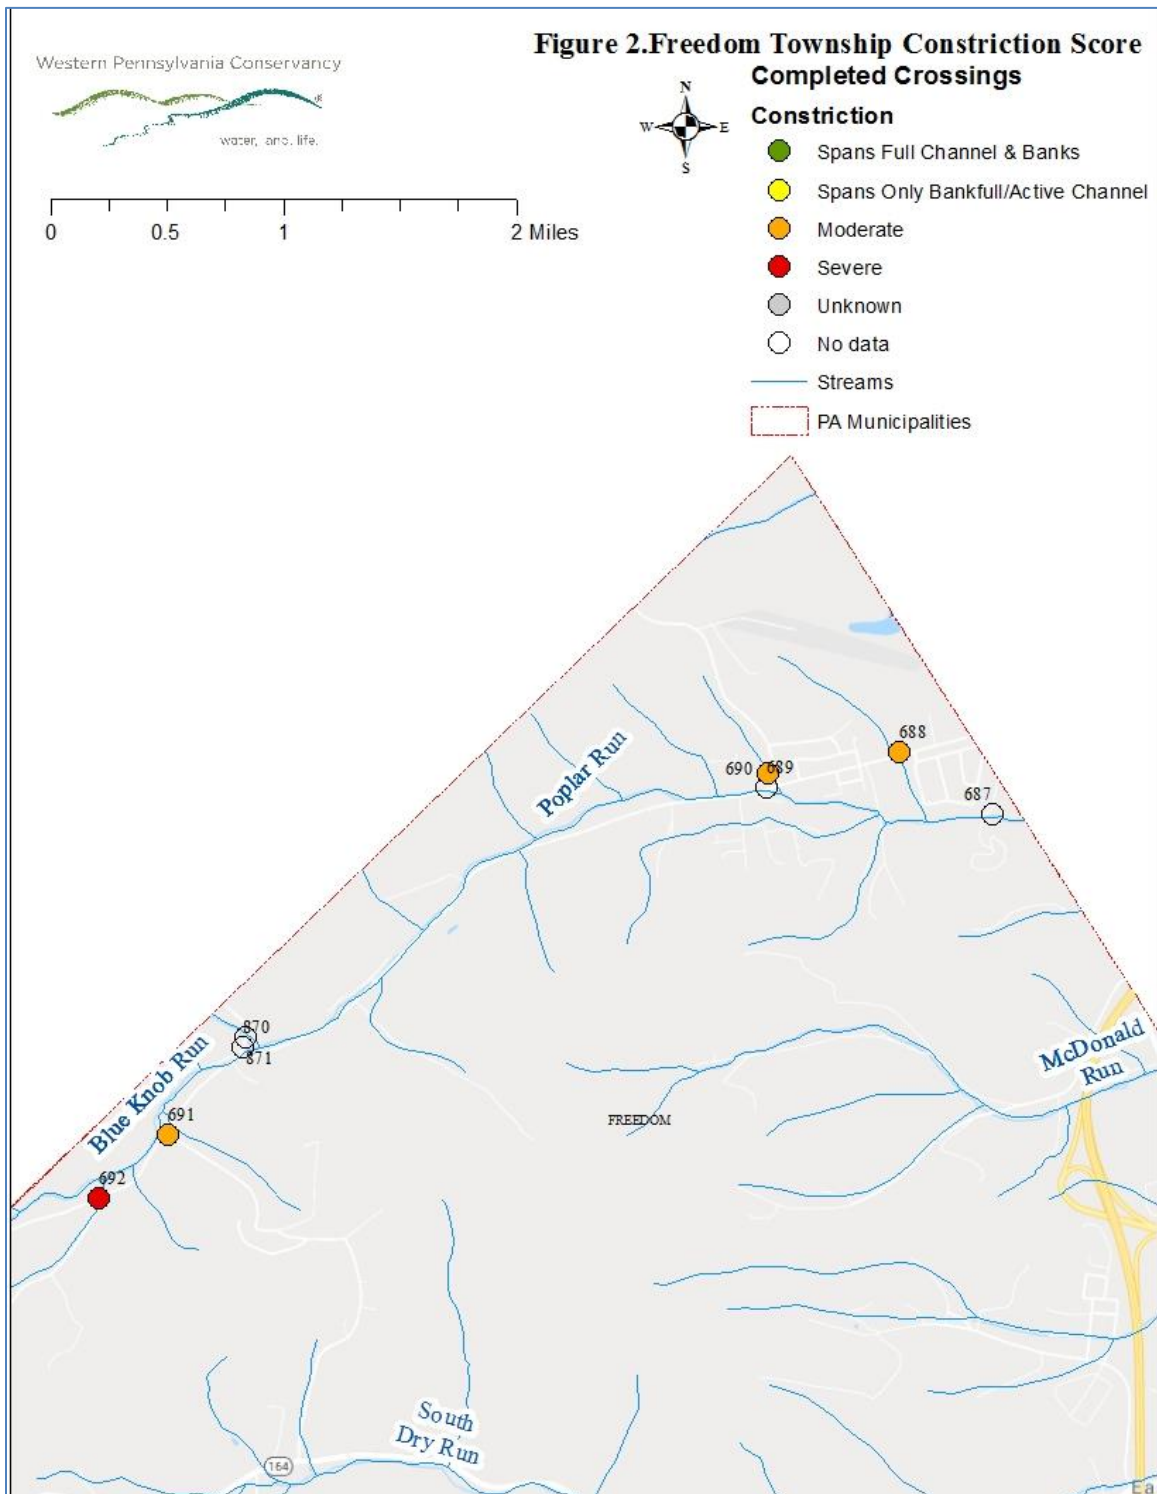
The constriction score assesses how the width of the crossing compares to the width of the natural stream channel. Road-stream crossings that have severe constriction scores are more likely to have erosion problems above and/or below the crossing. Figure 2 shows constriction scores for assessed crossings in Freedom Township. One crossing shows a severe constriction score, which increases the potential of erosion and sedimentation around that crossing.

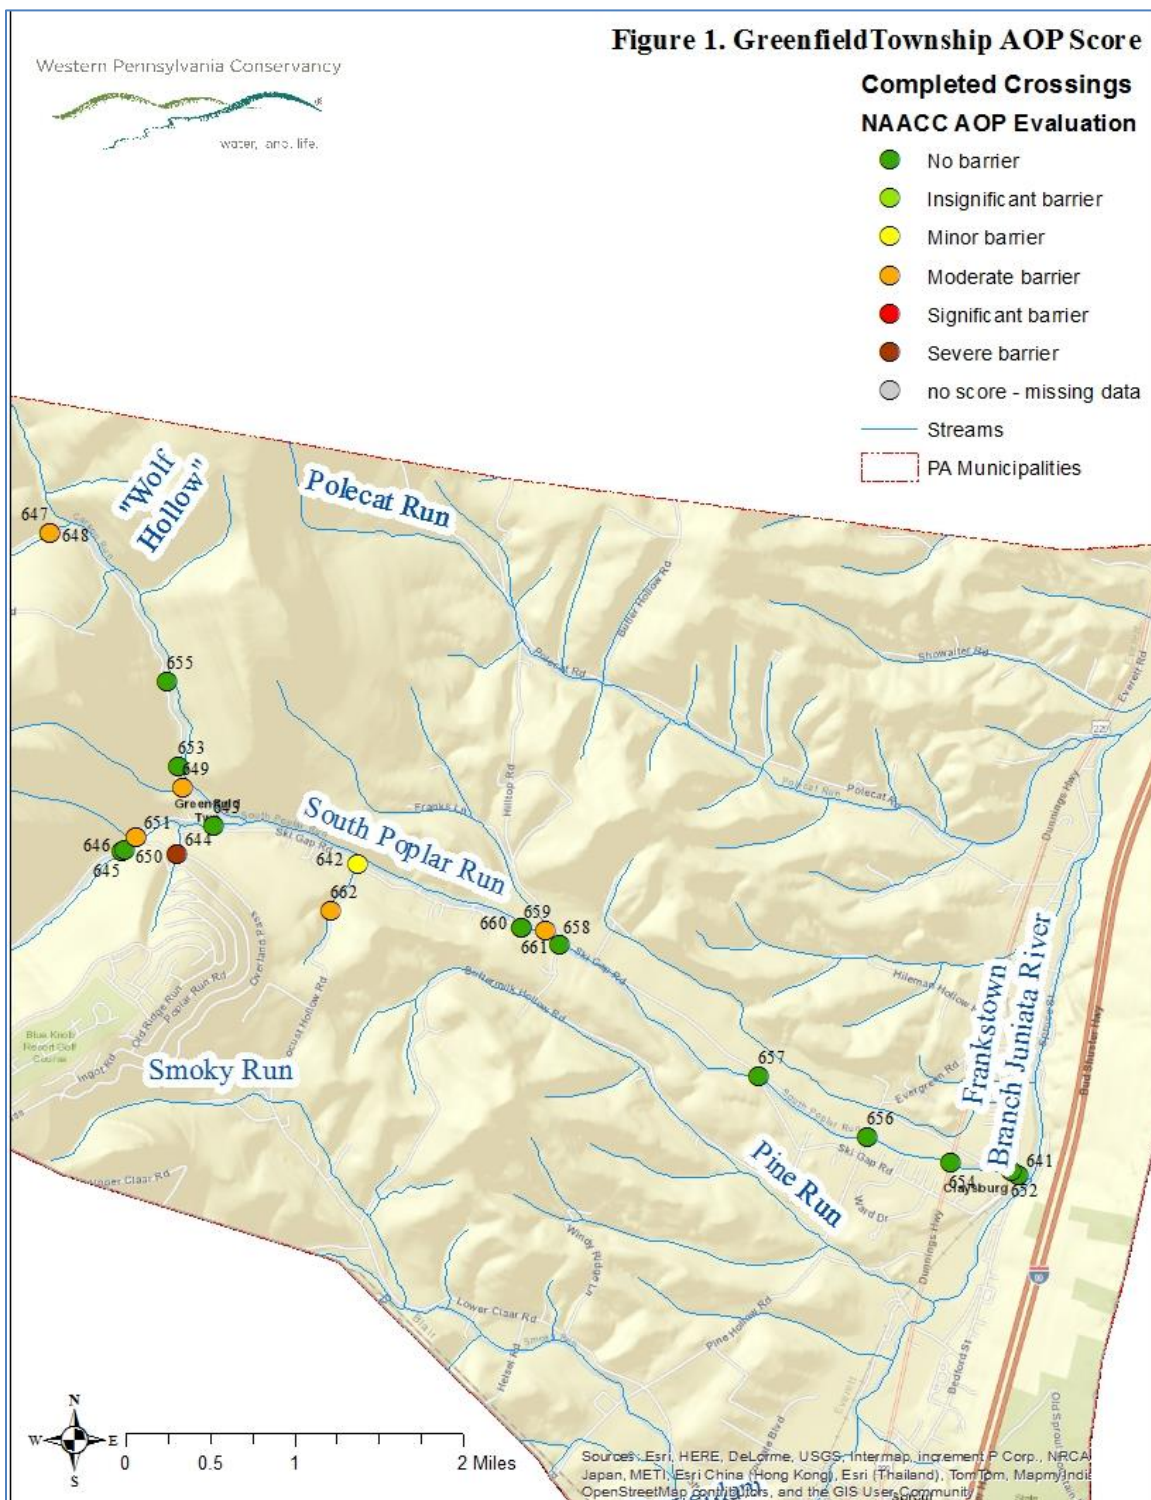
In Greenfield Township, 20 road-stream crossings were surveyed. Based upon NAACC assessment data, one of these crossings (644) was considered a severe aquatic organism passage (AOP) barriers (Figure 1).

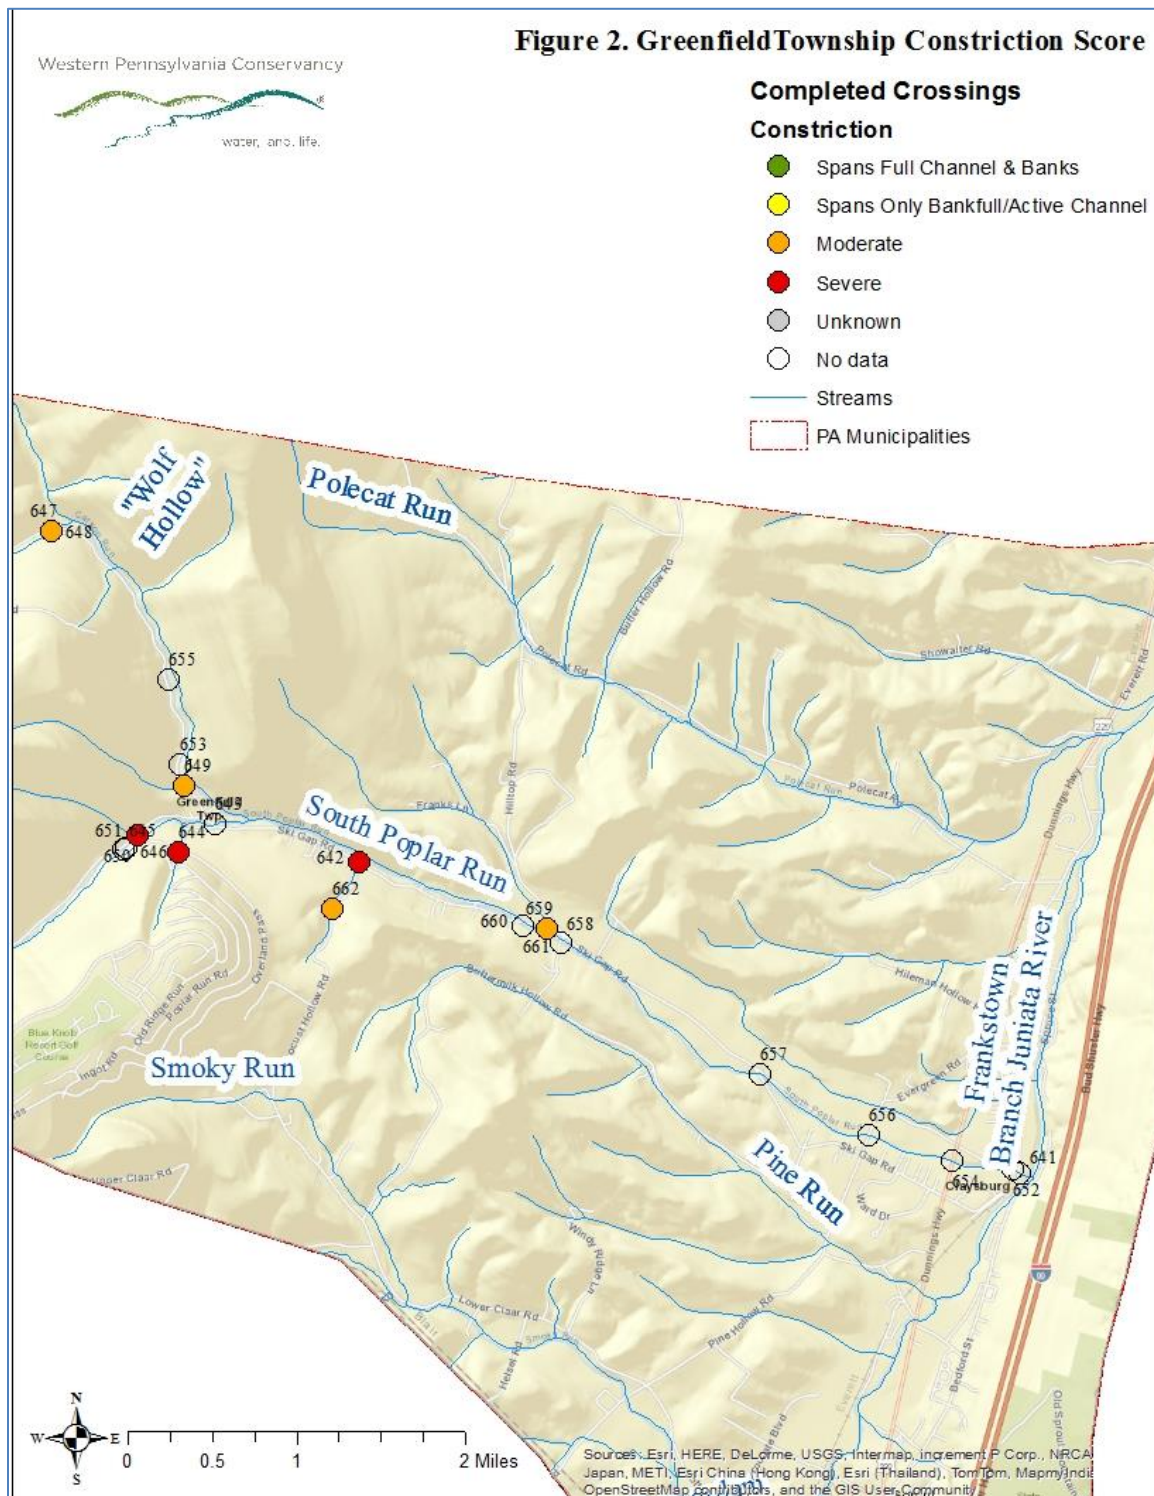
The constriction score assesses how the width of the crossing compares to the width of the natural stream channel. Road-stream crossings that have severe constriction scores are more likely to have erosion problems above and/or below the crossing. Figure 2 shows constriction scores for assessed crossings in Greenfield Township. Three crossings show severe constriction scores, which increases the potential of erosion and sedimentation around those crossings.

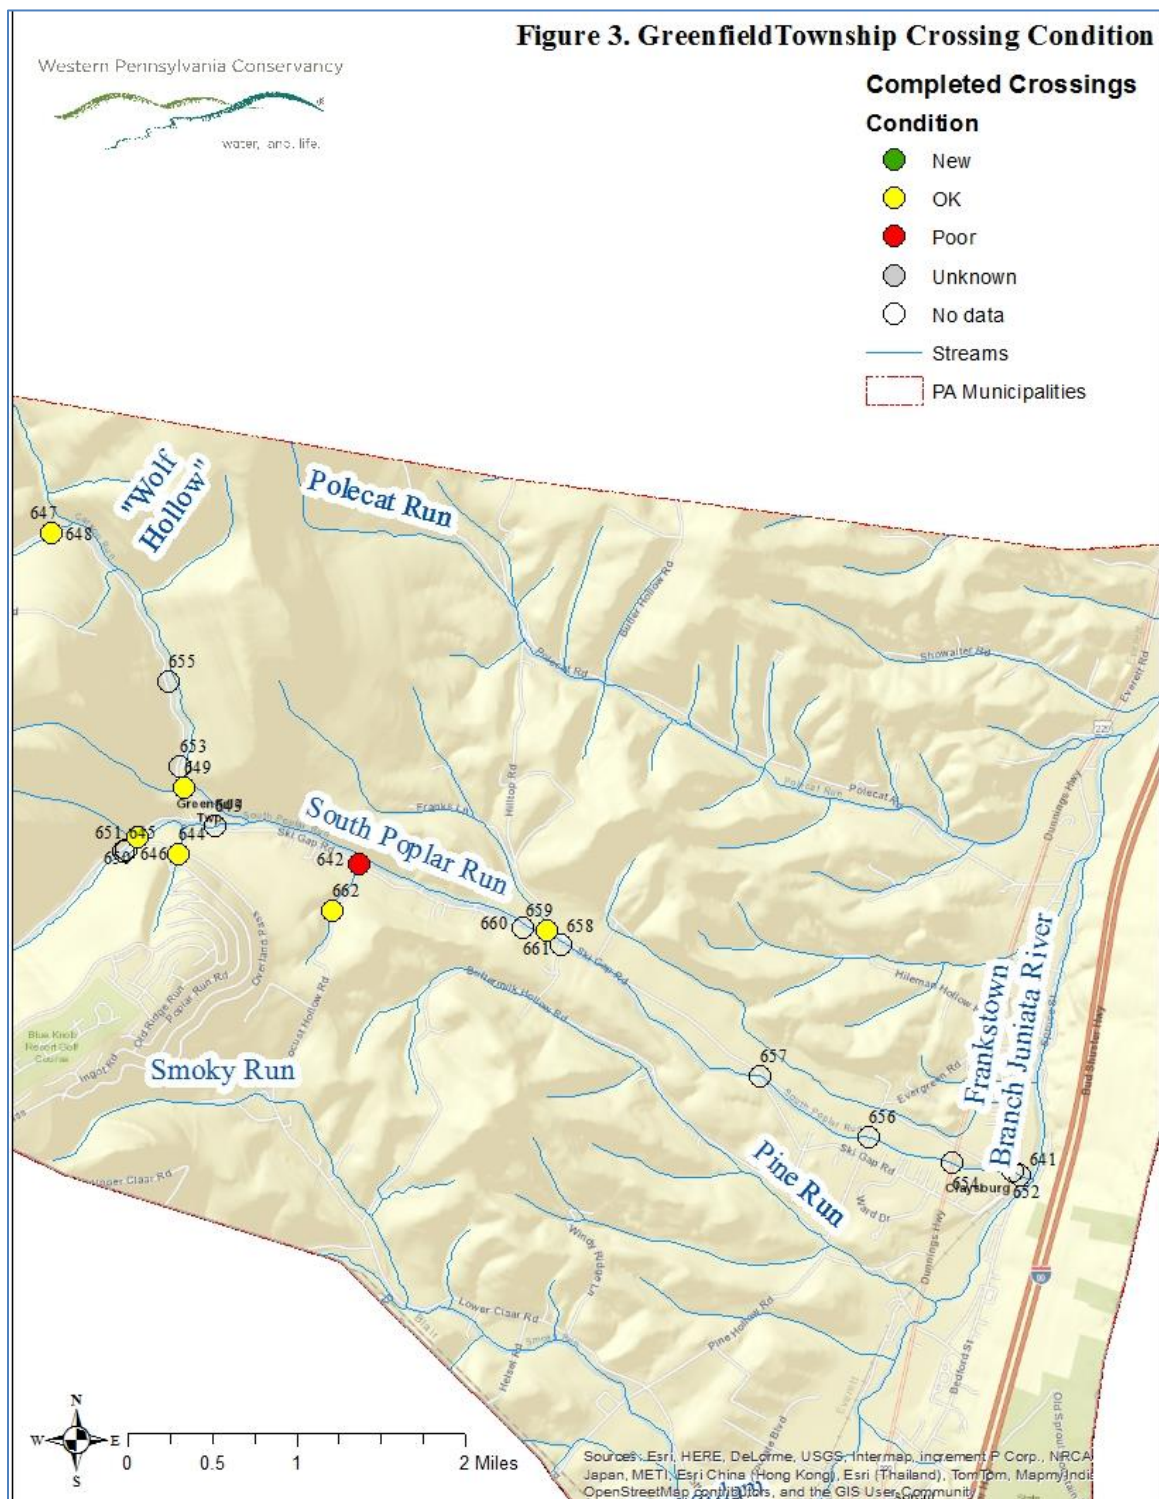
Crossing condition takes into account very old crossing pipes that are either rusting, collapsing, or eroding the road surface. One crossing (642) in the township had poor crossing conditions (Figure 3).

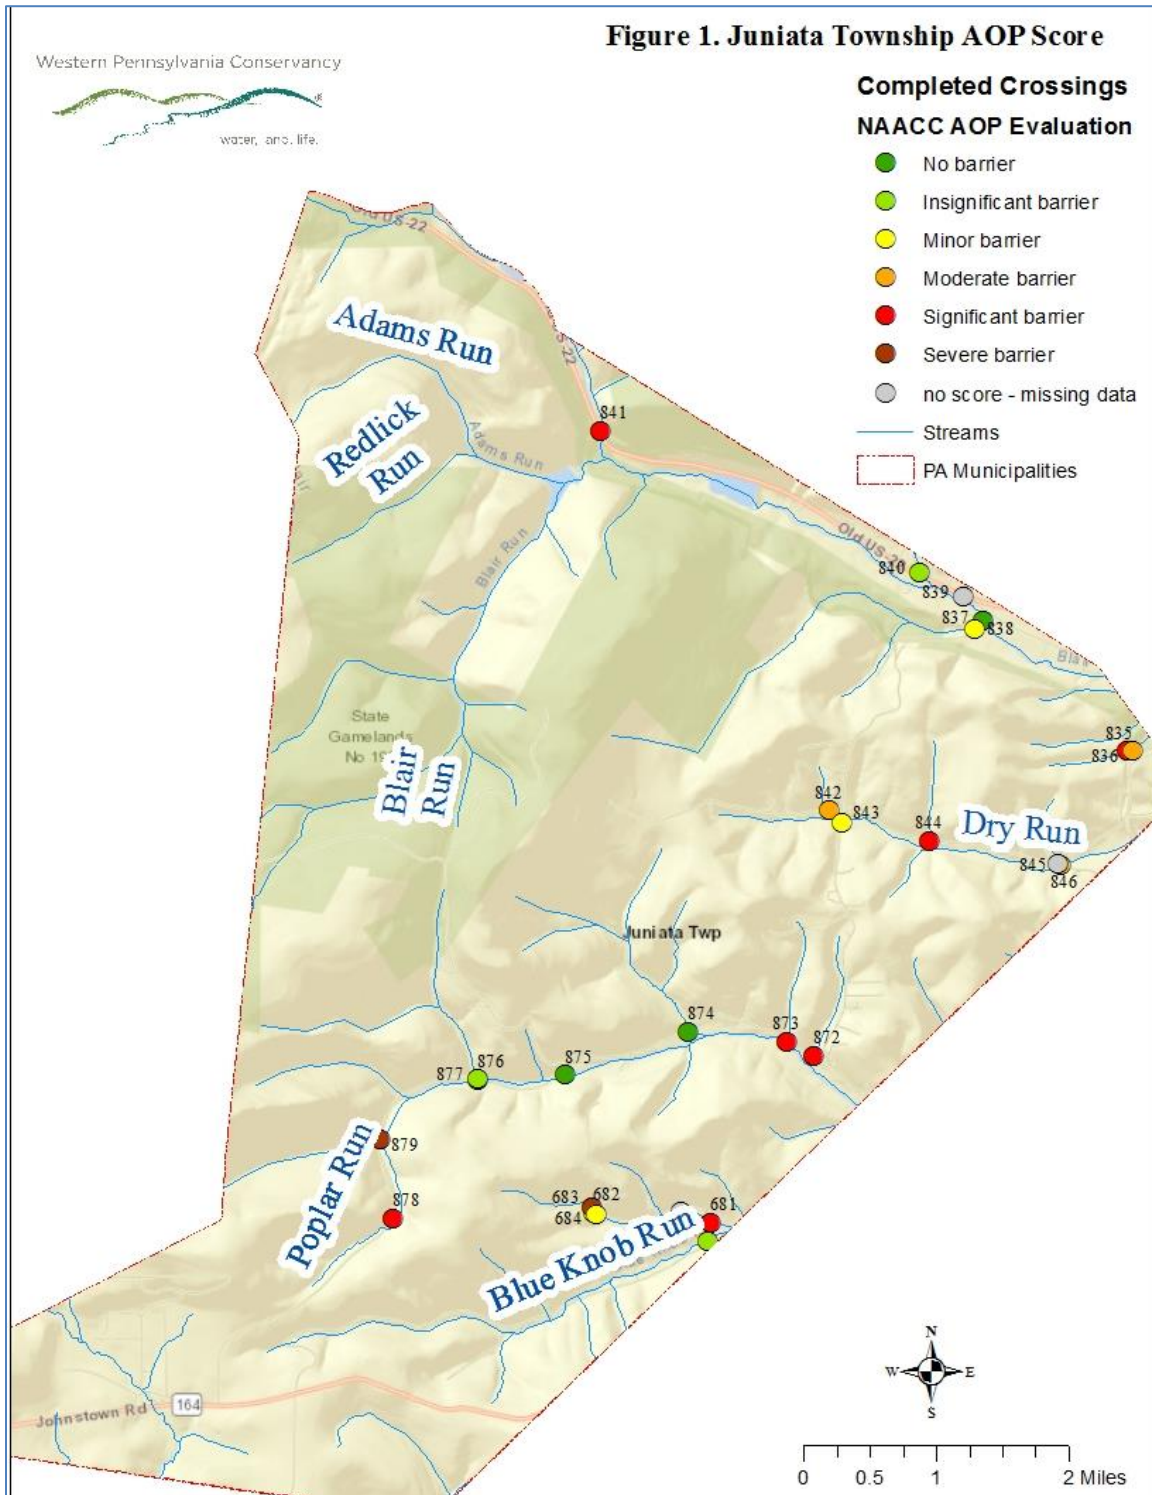
In Juniata Township, 26 road-stream crossings were surveyed. Based upon NAACC assessment data, two of these crossings (683 & 879) were considered severe aquatic organism passage (AOP) barriers and seven crossings (681, 872, 873, 878, 835, 841, & 844) were considered significant barriers (Figure 1).
