# BLAIR COUNTY ROAD-STREAM CROSSING ASSESSMENT

Prepared for:  
Blair County Conservation District  
1407 Blair Street  
Hollidaysburg, PA 16648

Prepared by:  
Western Pennsylvania Conservancy  
405 Allegheny Street  
Hollidaysburg, PA 16648  
(814) 696-9356

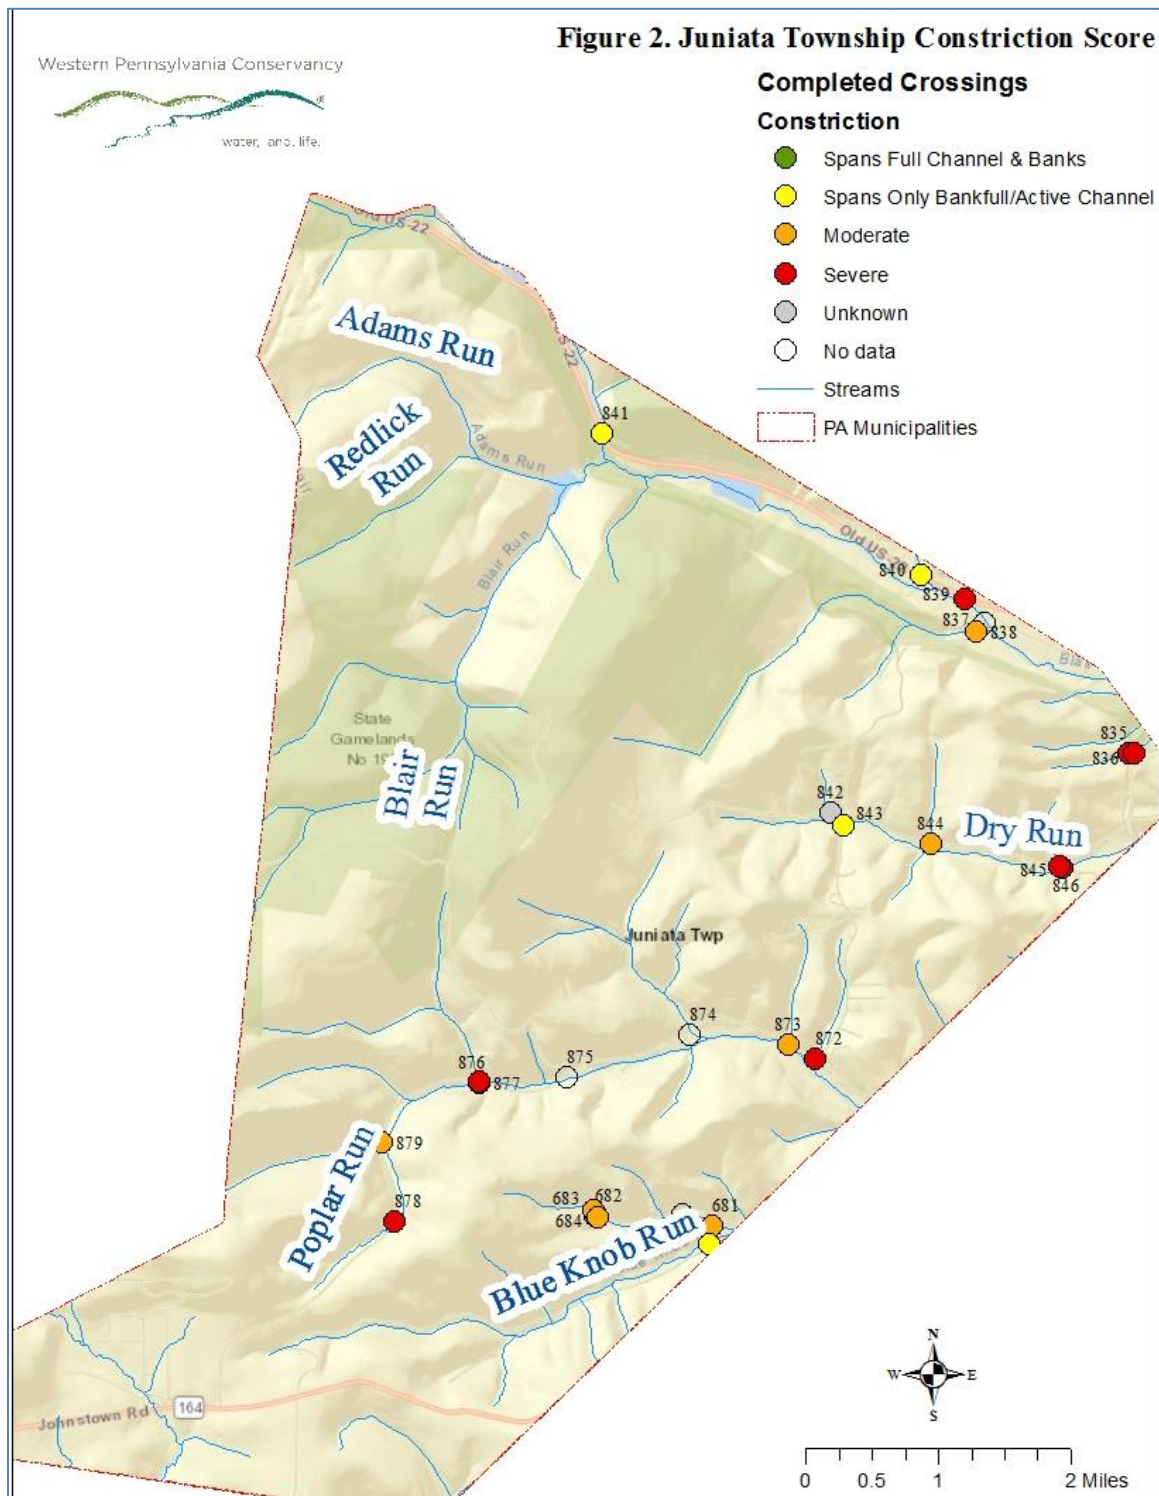
The constriction score assesses how the width of the crossing compares to the width of the natural stream channel. Road-stream crossings that have severe constriction scores are more likely to have erosion problems above and/or below the crossing. Figure 2 shows constriction scores for assessed crossings in Juniata Township. Eight crossings show severe constriction scores, which increases the potential of erosion and sedimentation around those crossings.

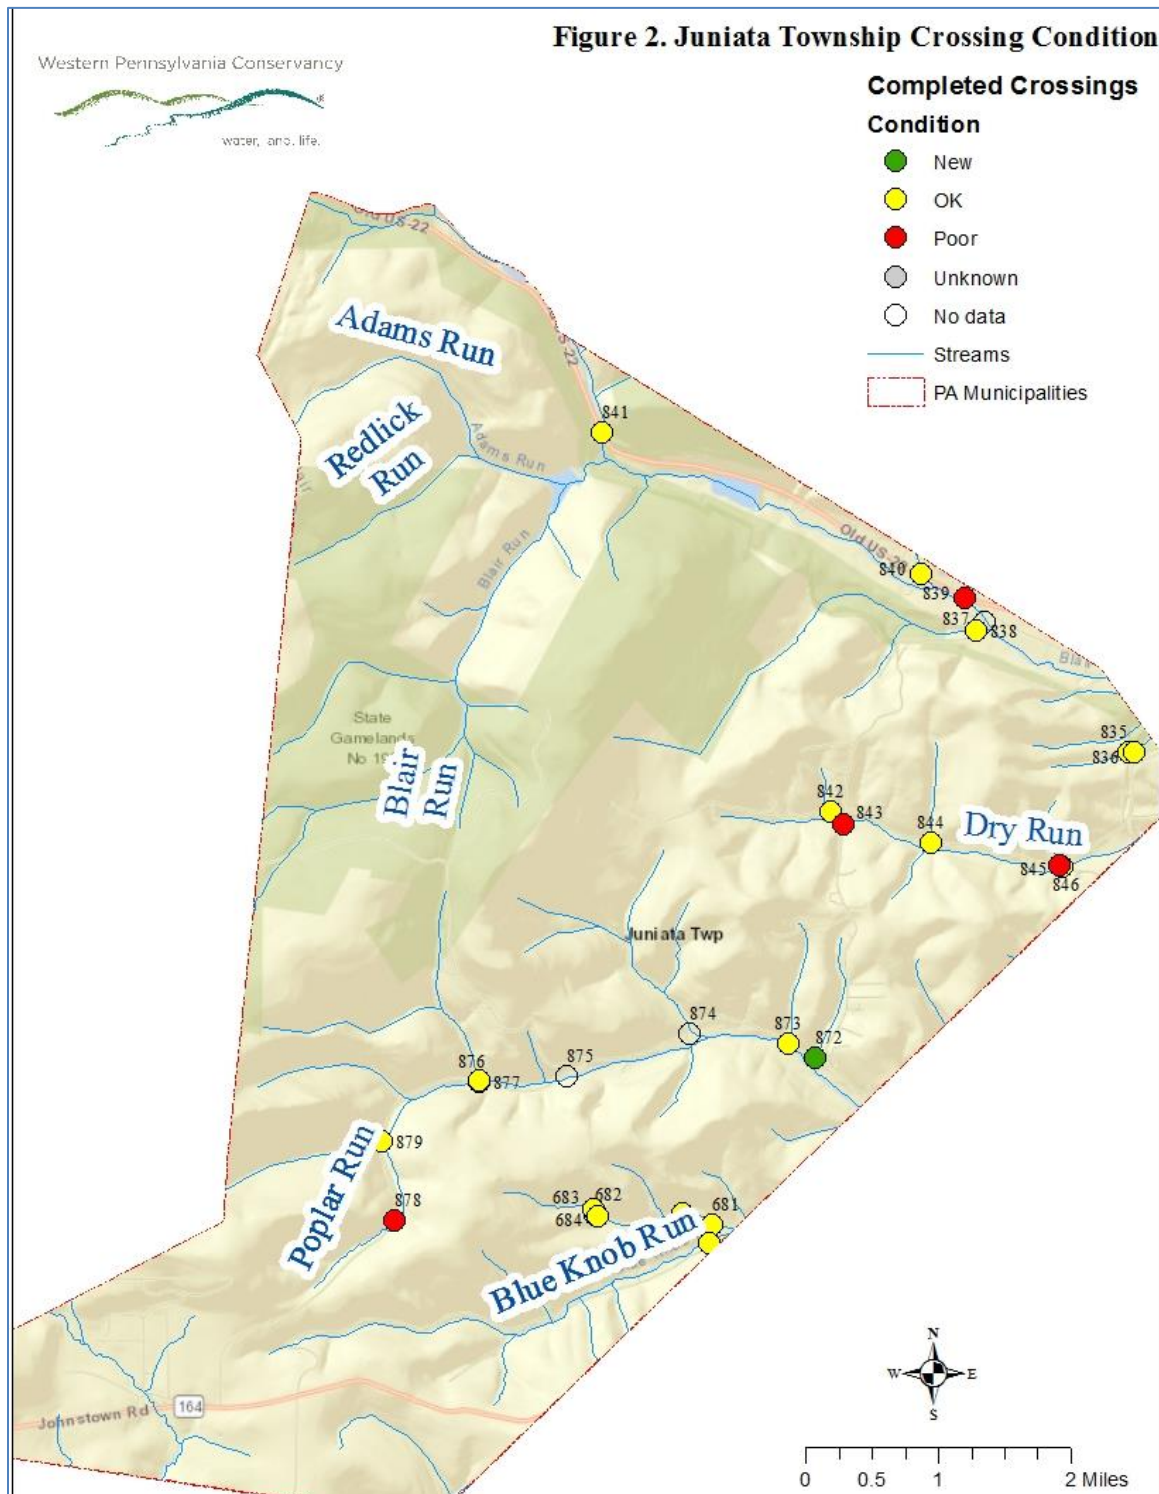
Crossing condition takes into account very old crossing pipes that are either rusting, collapsing, or eroding the road surface. Four crossings (839, 843, 845 & 878) in the township had poor crossing conditions (Figure 3). Crossing 837 was completely collapsed. We could not see the outlet pipe, and the stream is diverted into a road ditch. Crossing 878 had a slightly deformed pipe with the bottom rusted away.

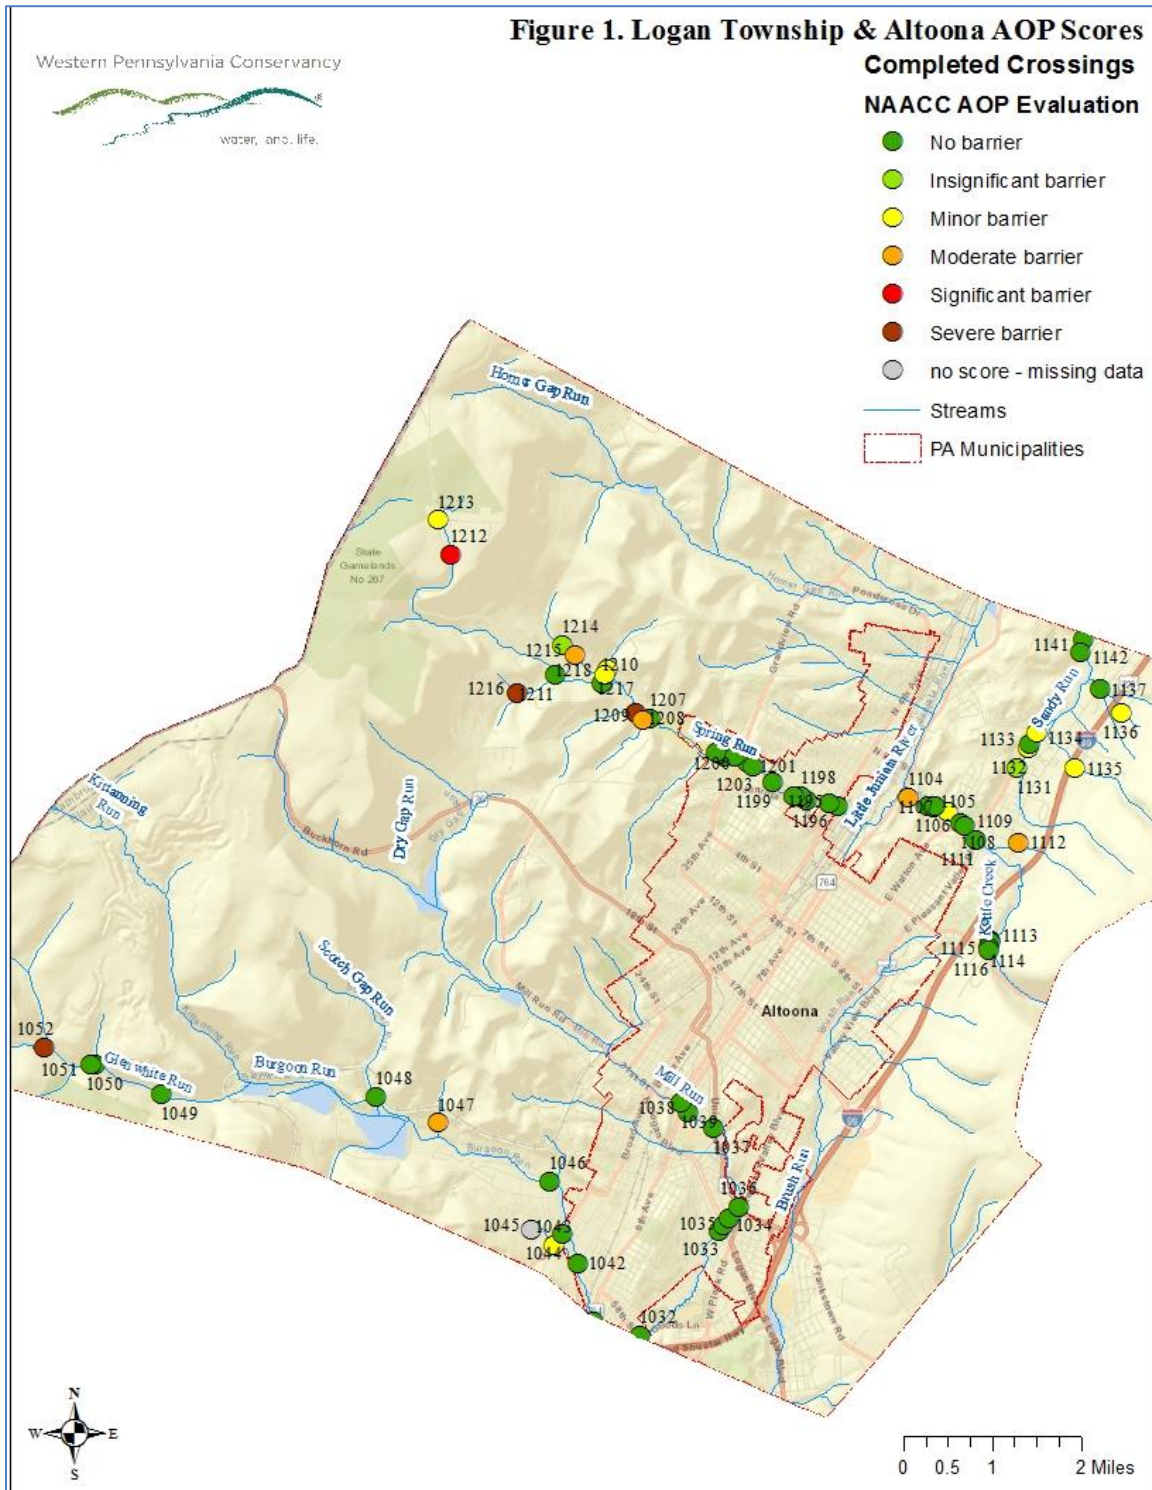
In Logan Township and Altoona, 64 road-stream crossings were surveyed. Based upon NAACC assessment data, three of these crossings (1052, 1208 & 1216) were considered to be severe aquatic organism passage (AOP) barriers and one of these crossings (1212) was considered to be a significant barrier to AOP (Figure 1).

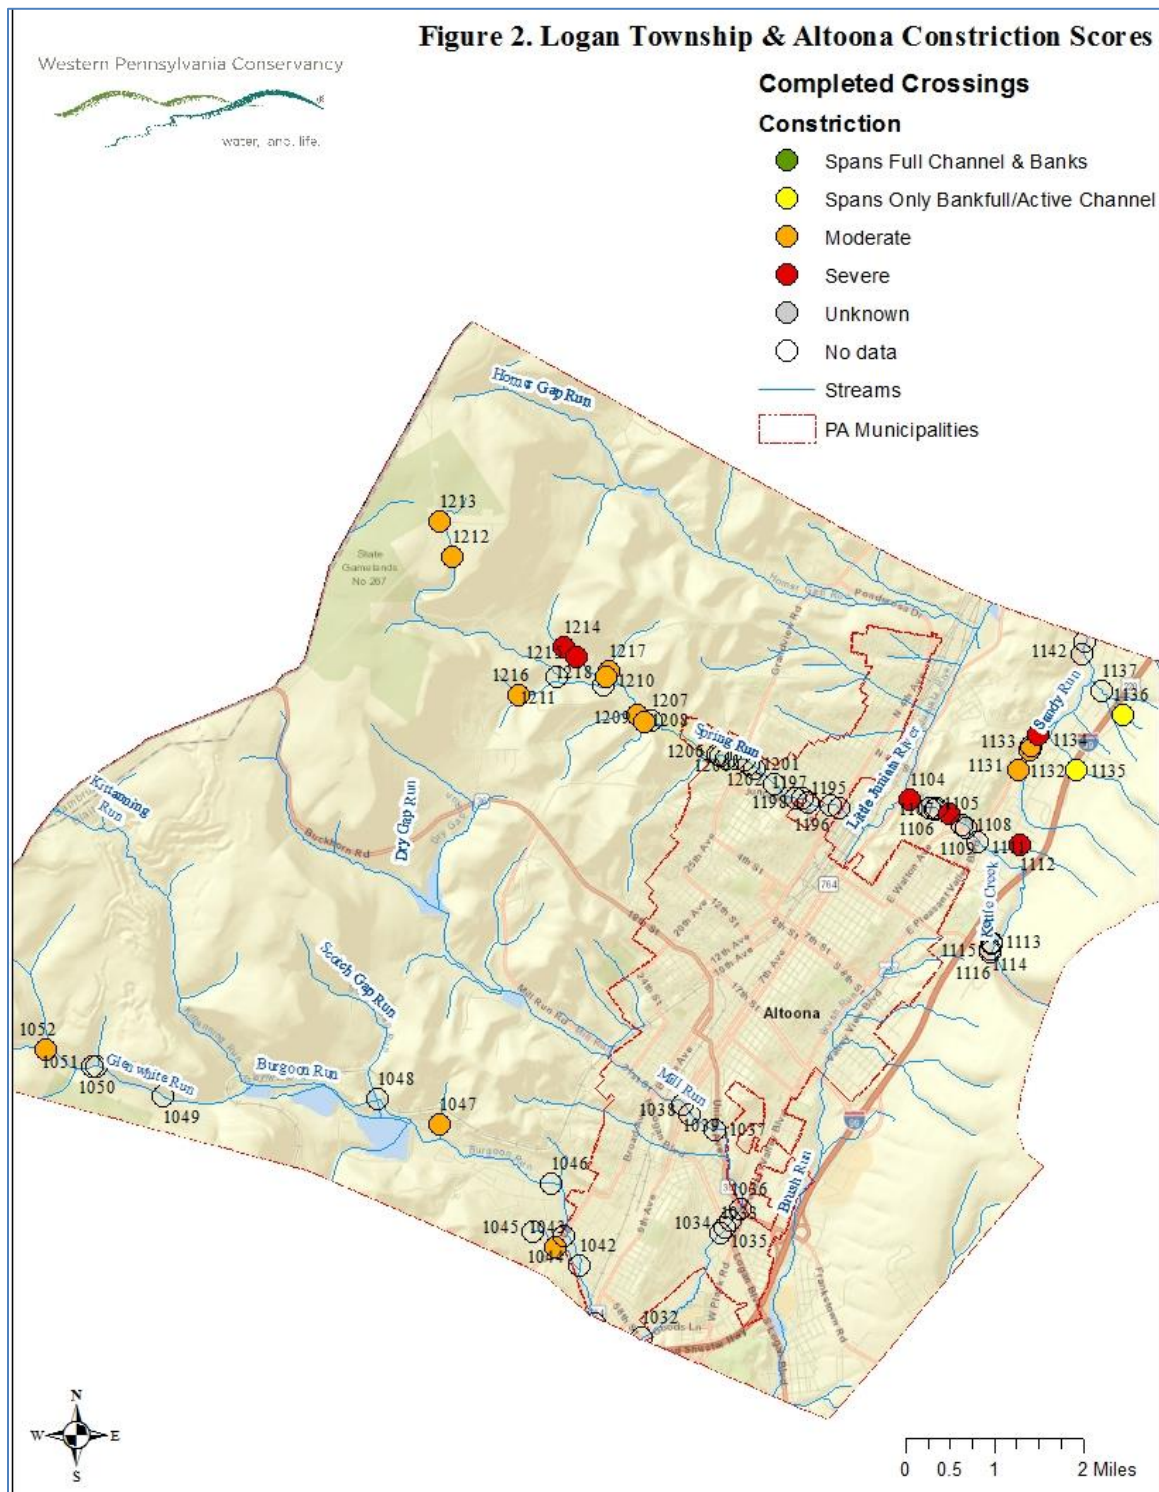
The constriction score assesses how the width of the crossing compares to the width of the natural stream channel. Road-stream crossings that have severe constriction scores are more likely to have erosion problems above and/or below the crossing. Figure 2 shows constriction scores for assessed crossings in Logan Township and Altoona. Six crossings show severe constriction scores, which increases the potential of erosion and sedimentation around those crossings.

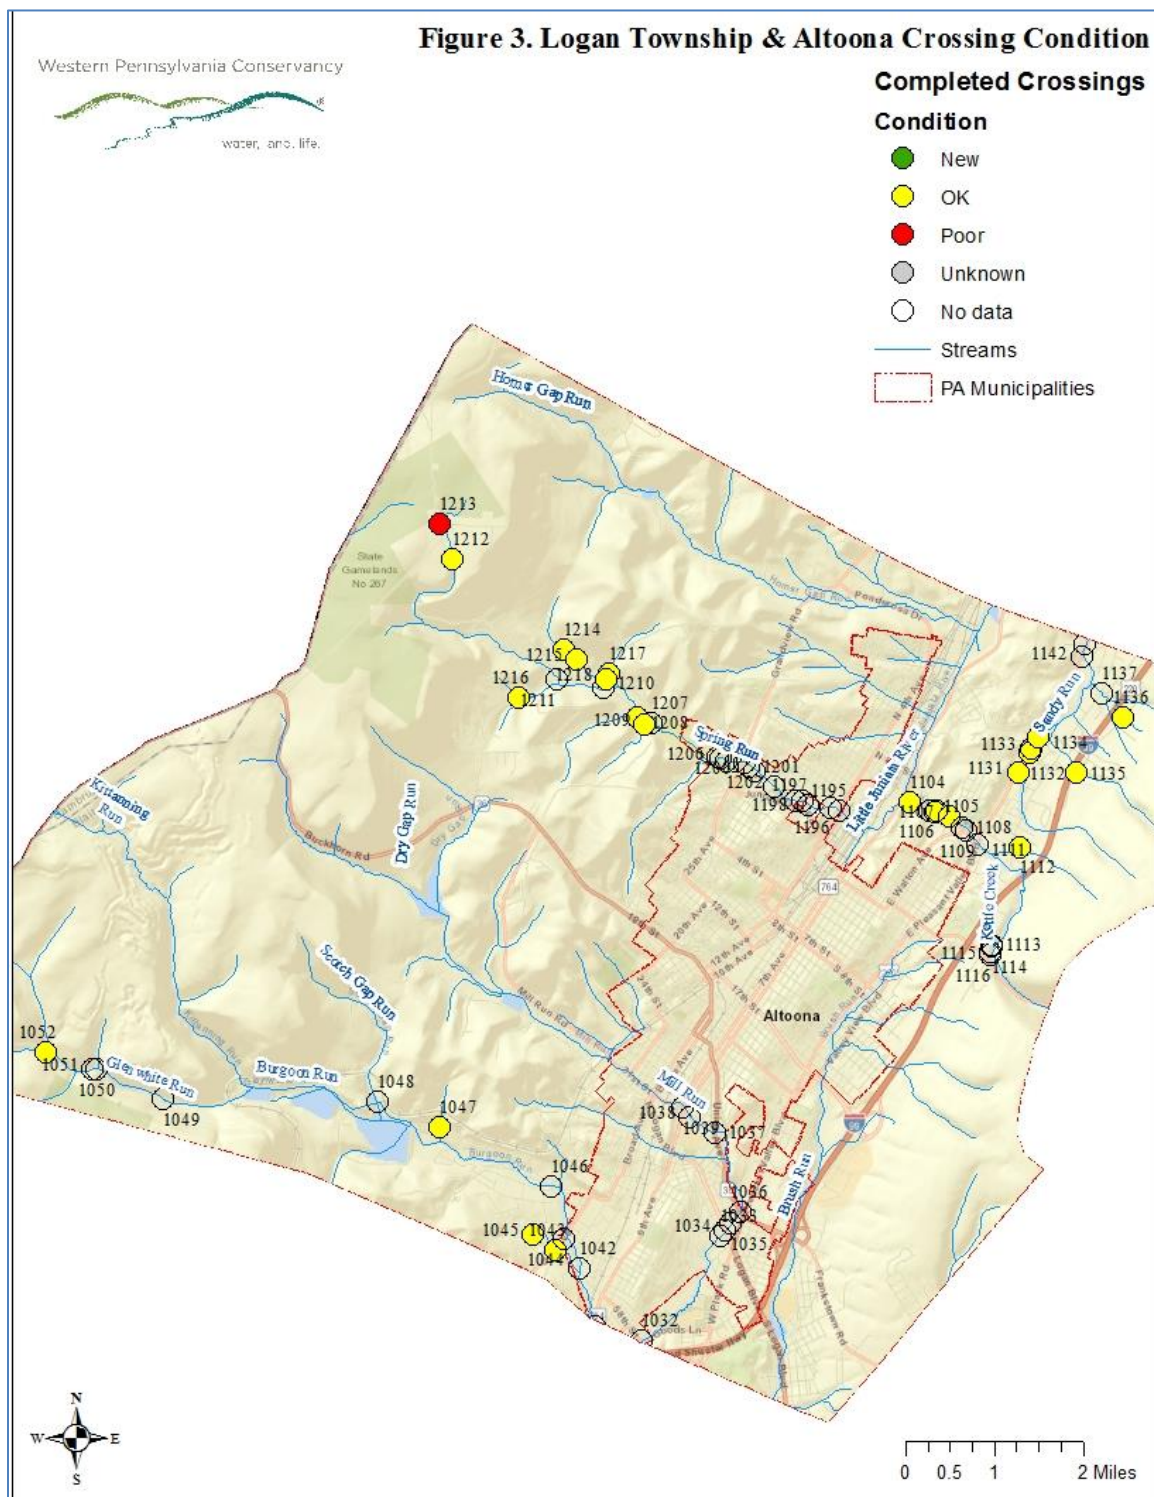
Another aspect of the NAACC protocol is to note crossings that are in poor condition. Logan Township had one crossing (1213) that was in poor condition (Figure 3).

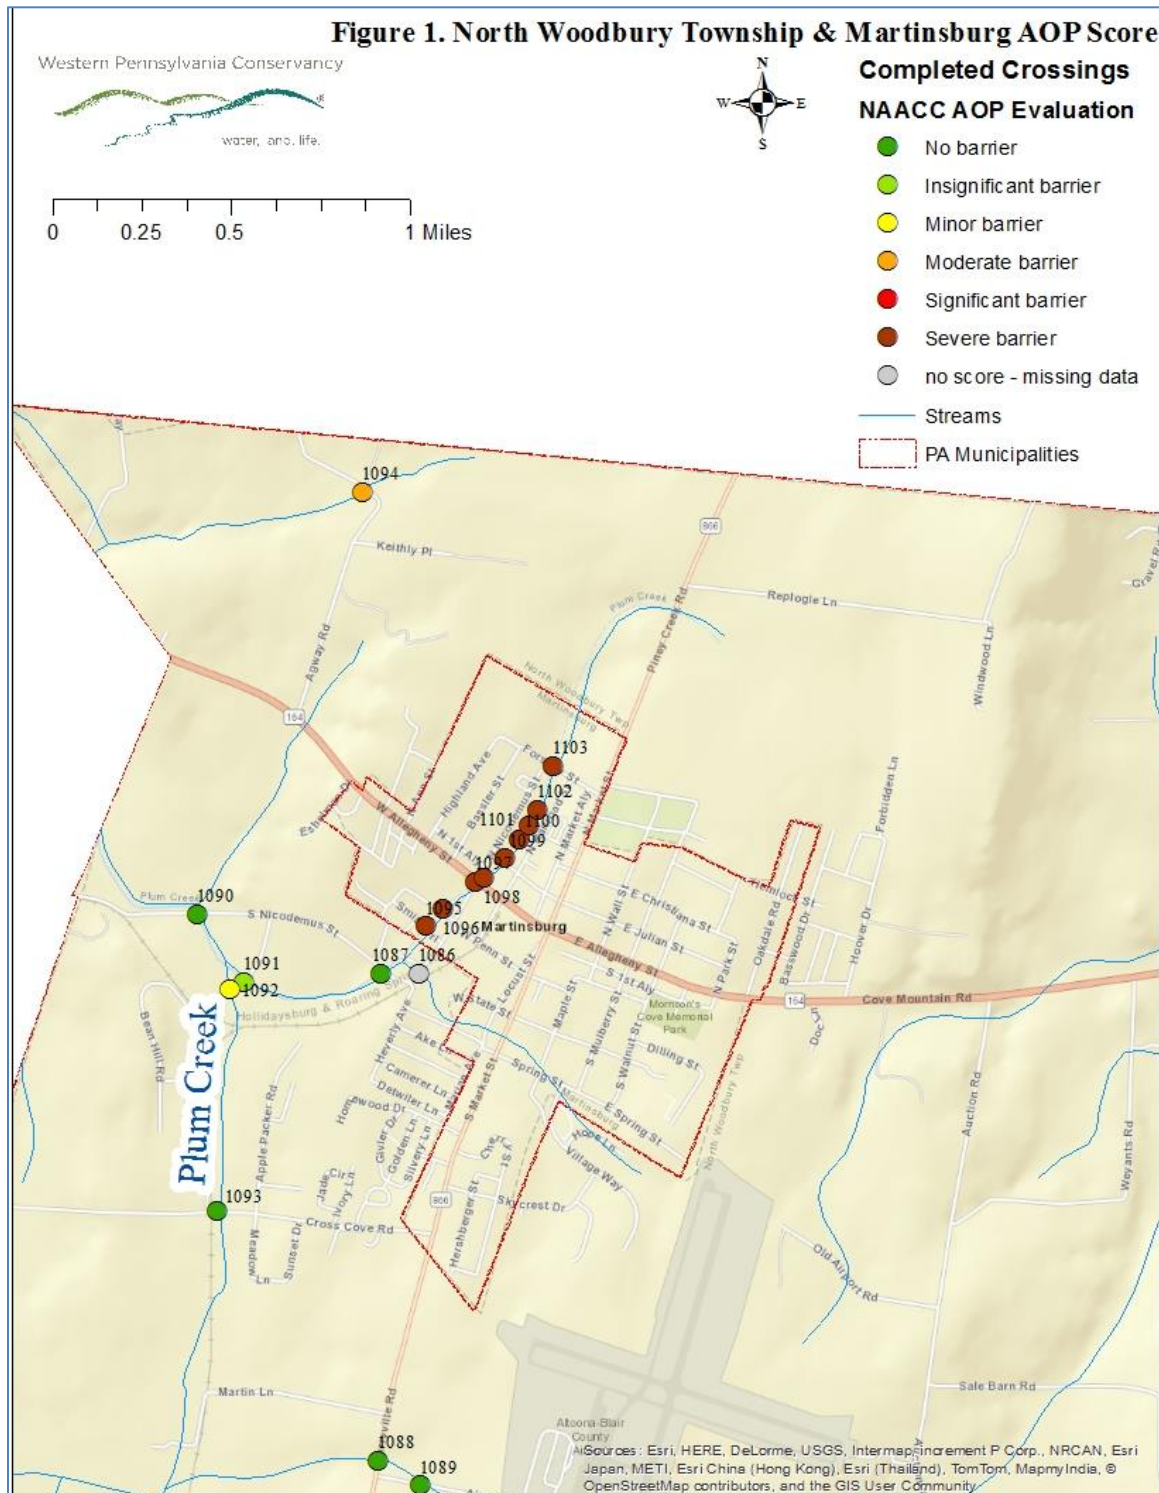
In North Woodbury Township and Martinsburg, 18 road-stream crossings were surveyed. Based upon NAACC assessment data, nine crossing in the Borough of Martinsburg were considered to be severe aquatic organism passage (AOP) barriers (Figure 1). This was due to the fact that all of the streams were piped underground. It was impossible to adequately assess these road stream crossings.

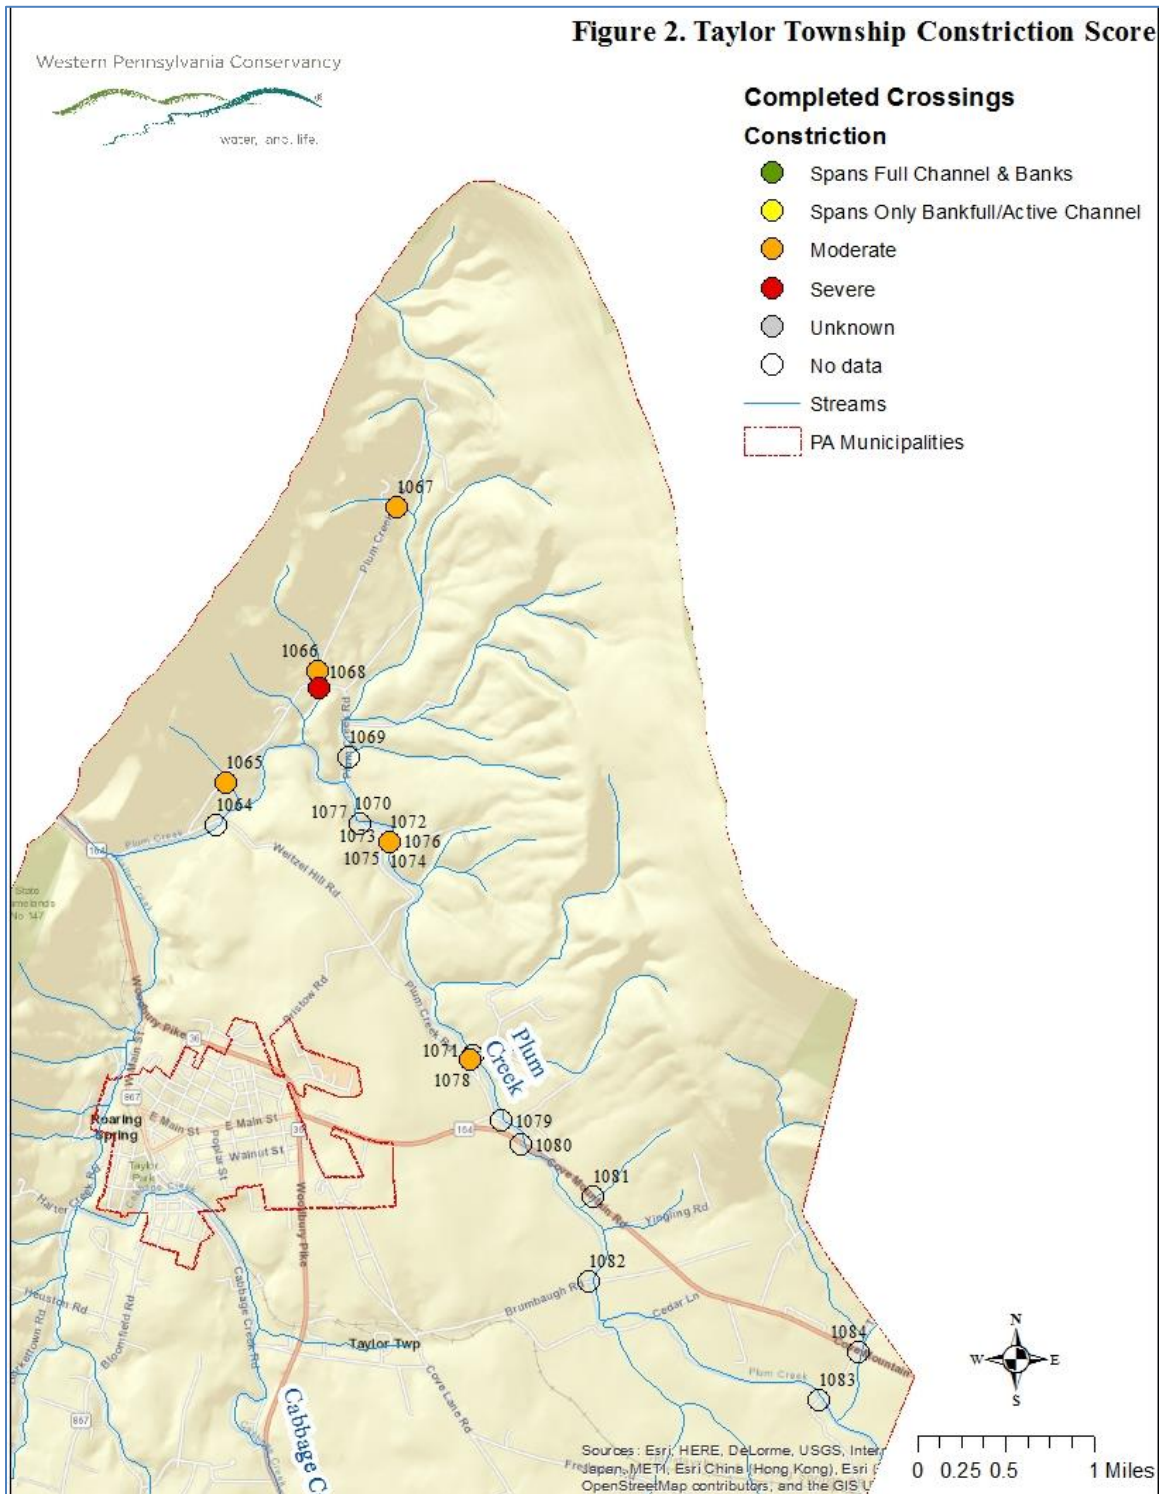
The constriction score assesses how the width of the crossing compares to the width of the natural stream channel. Road-stream crossings that have severe constriction scores are more likely to have erosion problems above and/or below the crossing. Figure 2 shows constriction scores for assessed crossings in Taylor Township. One crossing shows a severe constriction score, which increases the potential of erosion and sedimentation around those crossings.

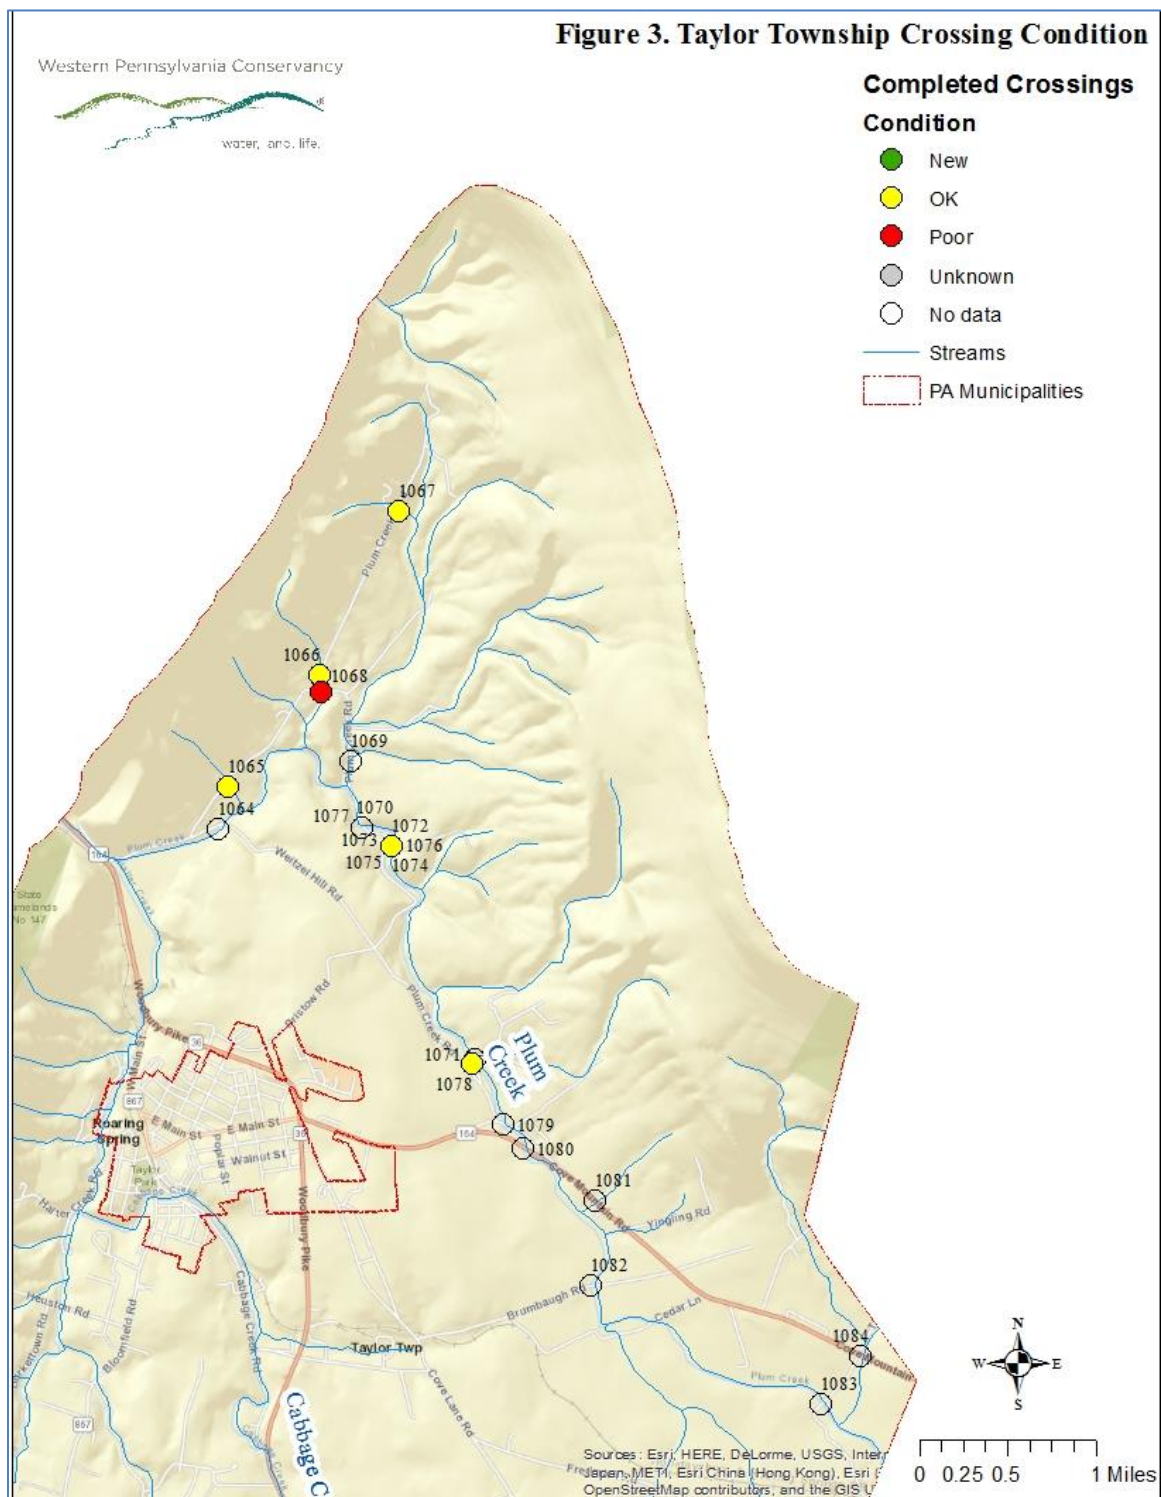
Another aspect of the NAACC protocol is to note crossings that are in poor condition. Taylor Township had one crossing (1068) that was in poor condition (Figure 3).

A NAACC evaluation of a crossing site yields information about existing barriers, constriction status, and the general condition of the crossing. When a crossing has severe or poor issues in any one of these categories, it is recommended that efforts be made to improve or replace the structure at that crossing point (Table 1). It is encouraged that crossing sites that have marks in more than one of these categories rank higher in priority for replacement.

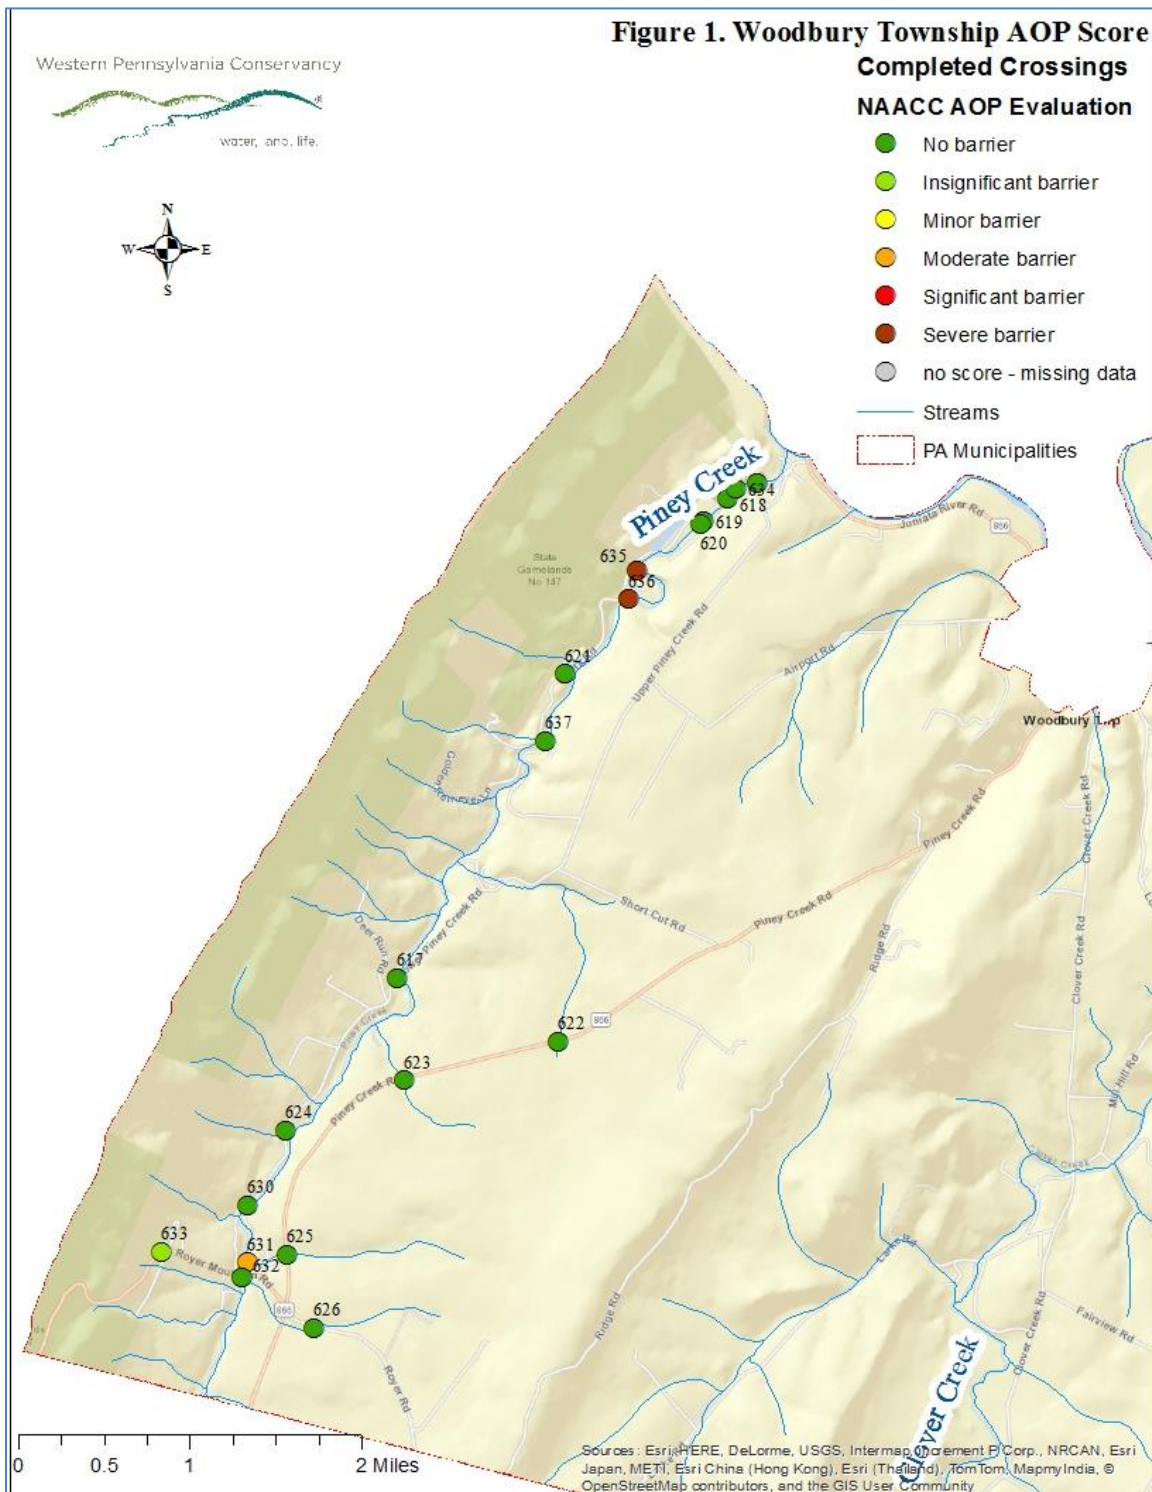
In Woodbury Township, 19 road-stream crossings were surveyed. Based upon NAACC assessment data, two of these crossings (635 & 636) were considered to be severe aquatic organism passage (AOP) barriers (Figure 1).

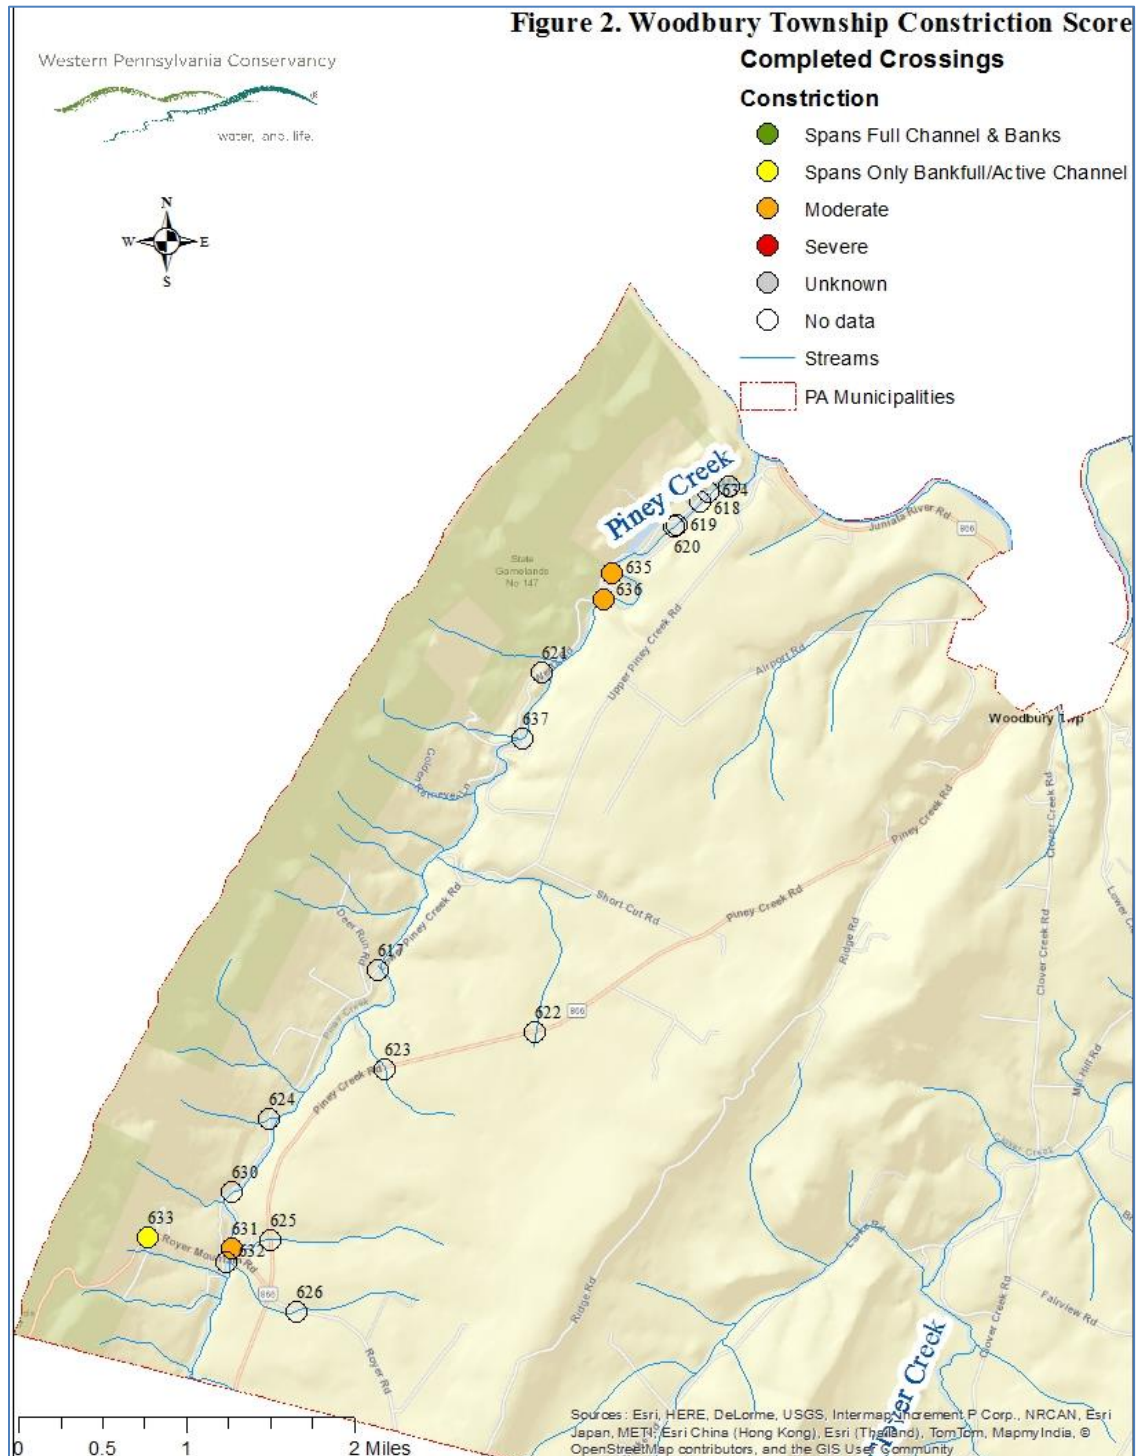
The constriction score assesses how the width of the crossing compares to the width of the natural stream channel. Road-stream crossings that have severe constriction scores are more likely to have erosion problems above and/or below the crossing. Figure 2 shows constriction scores for assessed crossings in Woodbury Township. No crossings show severe constriction scores. Crossings shown in Figure 2 that have a “No data” score are bridges where constriction was not measured because the crossings are not considered AOP barriers.

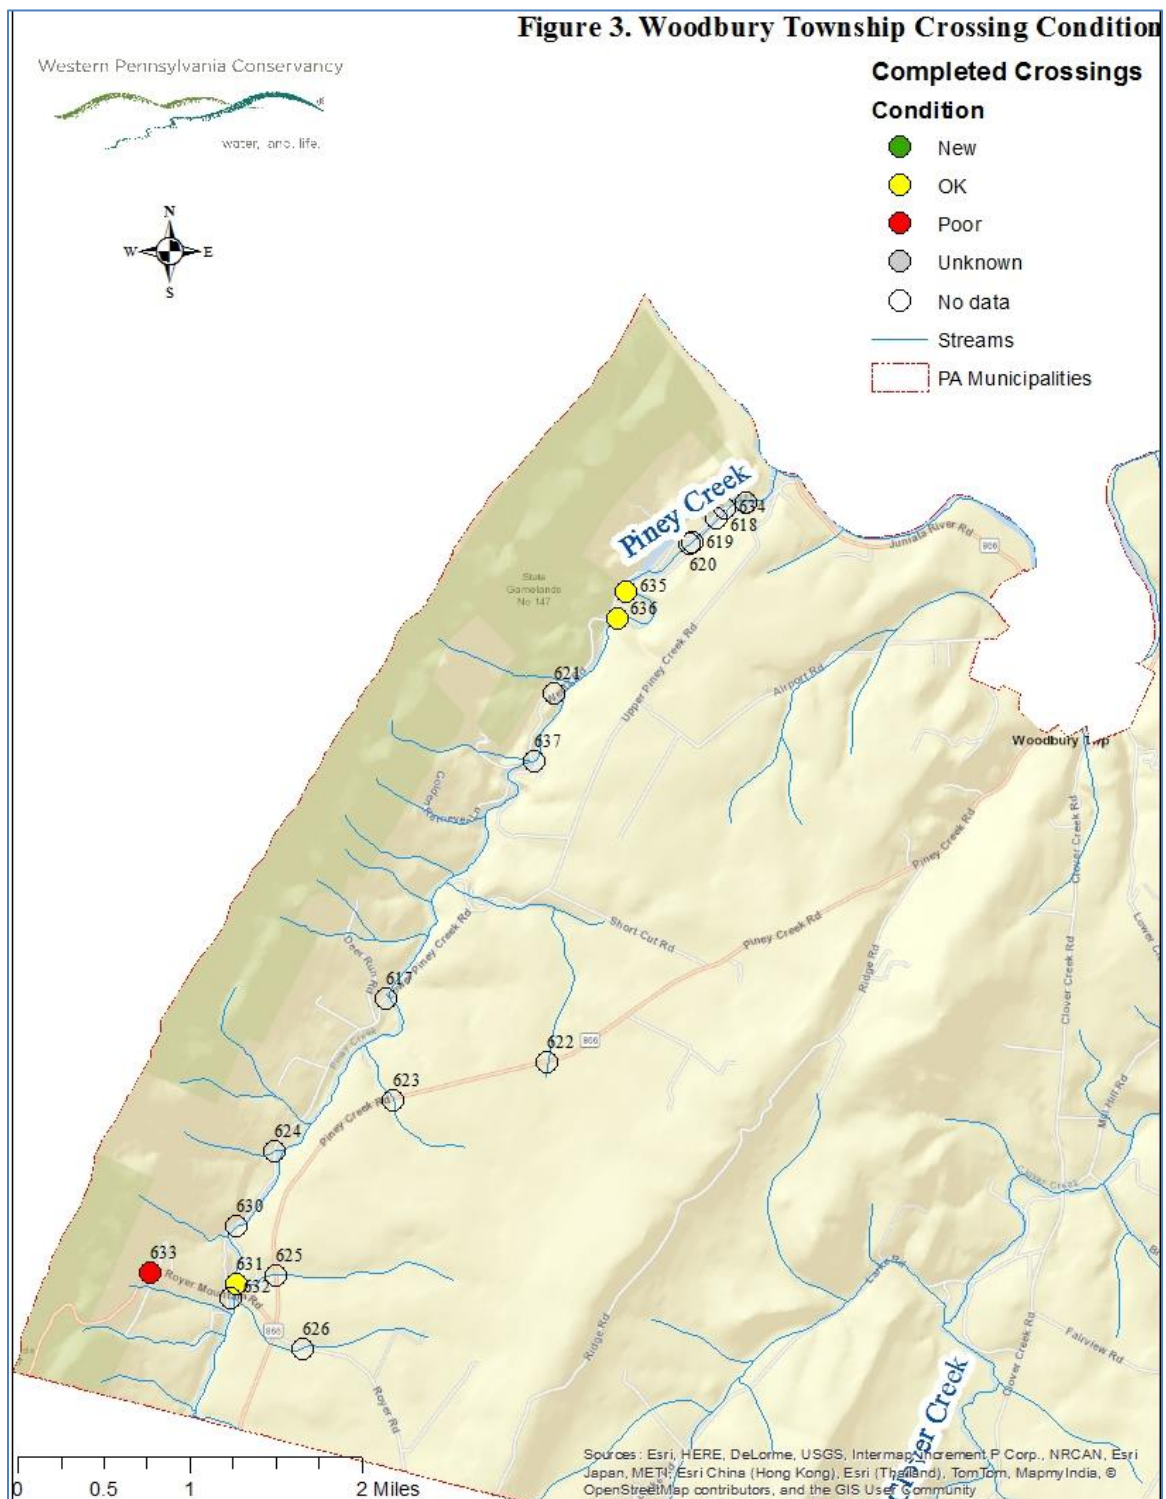
Another aspect of the NAACC protocol is to note crossings that are in poor condition. Woodbury Township had one crossing (633) that was in poor condition (Figure 3).

A NAACC evaluation of a crossing site yields information about existing barriers, constriction status, and the general condition of the crossing. When a crossing has severe or poor issues in any one of these categories, it is recommended that efforts be made to improve or replace the structure at that crossing point (Table 1). It is encouraged that crossing sites that have marks in more than one of these categories rank higher in priority for replacement.
